| Intersection ID: 19118 | Main Street: BEVERWYCK_RD | Cross Street: COLONY_RD | Location: | NE |
| ADA ID: 32B89698C518 | Ramp Type: PerpDiag | Initial Pass/Fail: Pass | Overall Compliance: No | Severity Score: 10.25 |

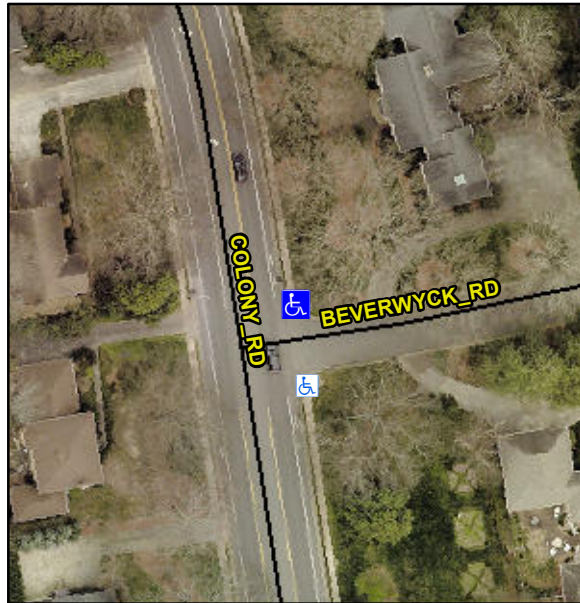
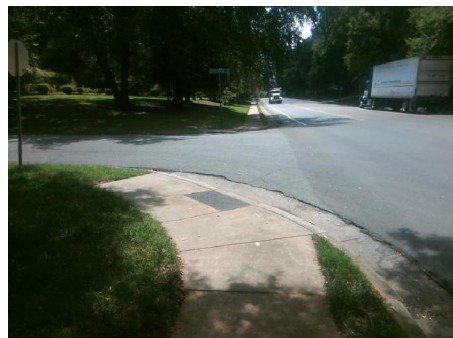
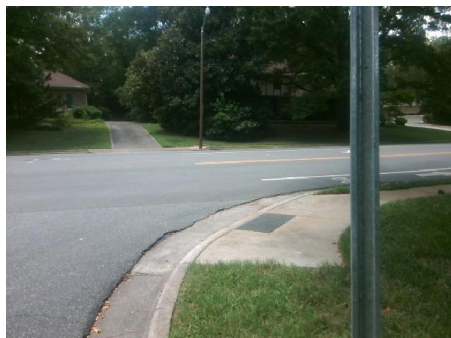
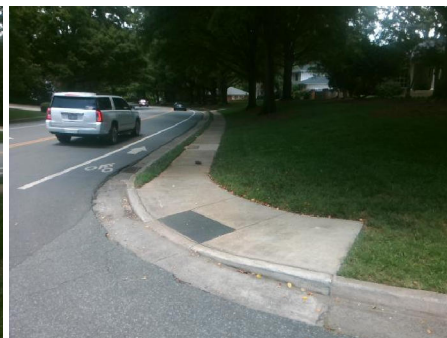
| Compliance | Description | Data | Compliance | Description | Data |
|---|---|---|---|---|---|
| N/A | Ramp Length (in) | 65.0 | Yes | Ramp Slope (%) | 5.3 |
| Yes | Ramp Width (in) | 49.0 | No | Ramp XSlope (%) | 3.6 |
| No | Landing Length (in) | N/A | Yes | DWS Provided? | Yes |
| No | Landing Width (in) | N/A | Yes | DWS Contrast? | Yes |
| No | Landing Slope (%) | N/A | Yes | DWS Length (in) | 24.5 |
| No | Landing X Slope (%) | N/A | Yes | DWS Full Width? | Yes |

**Remove & Replace Curb Ramp With Two New Directional Ramps or Equivalent.**

Total Cost: \$ 3200.00
