Access Compliance Report

Public Rights-of-Way

(Curb Ramps)

Intersection ID: 14864	Main Street: E_TREMONT_AV	Cross Street: LENNOX_AV	Location: W
ADA ID: 32CABDBD7070	Ramp Type: Directional1	Initial Pass/Fail: Fail	Overall Compliance: No
		Severity Score: 12.5

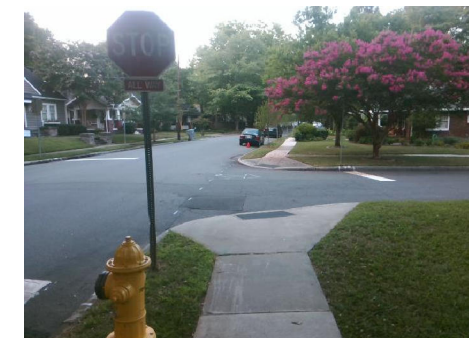
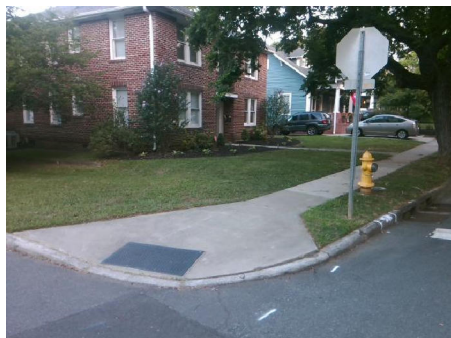
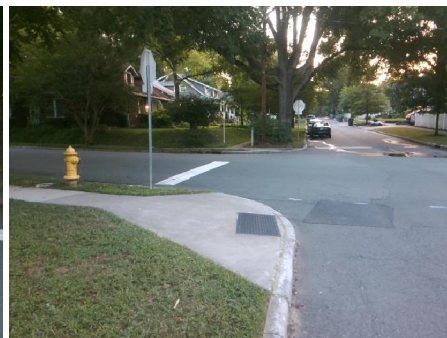
R304.2.2

Compliance	Description	Data	Compliance	Description	Data
N/A	Ramp Length (in)	108.0	N/A	Grade Break?	N/A
Yes	Ramp Width (in)	48.0	N/A	Grade Break Slope (%)	0.0
No	Ramp Slope (%)	8.9	N/A	Grade Break XSlope (%)	0.0
Yes	Ramp XSlope (%)	0.7			
N/A	Flare Type LT	N/A	N/A	Flare Type RT	N/A
N/A	Flare Slope LT (%)	N/A	N/A	Flare Slope RT (%)	0.0
N/A	Flare Traversable LT?	N/A	N/A	Flare Traversable RT?	N/A
N/A	Landing Length (in)	0.0	N/A	DWS Provided?	N/A
N/A	Landing Width (in)	0.0	N/A	DWS Contrast?	N/A
N/A	Landing Slope (%)	0.0	N/A	DWS Length (in)	N/A
N/A	Landing X Slope (%)	0.0	N/A	DWS Full Width?	N/A
N/A	Landing Curb? (Y/N)	N/A	N/A	DWS Offset LT (in)	N/A
N/A	Shared Landing?	N/A	N/A	DWS Offset RT (in)	N/A
N/A	Gutter Ponding?	0.0	N/A	Gutter Slope (%)	N/A
N/A	Gutter Lip Ht (in)	1.0	N/A	Gutter X Slope (%)	N/A
N/A	Painted X Walk1?	No		Road Slope (%)	3.0
	X Walk 1 Direction	To SE		Road X Slope (%)	4.9
	X Walk 1 Width (in)	N/A		Clear Space?	N/A

X Walk 1 Slope (%)	3.0	N/A	Clear Space to XWalk (in)	N/A
	X Walk 1 X Slope (%)	4.9	N/A	Storm Grate/Utility Hazard?	N/A
N/A	Ramp inside XWalk1?	N/A		Storm Grate/Utility Type	
N/A	Any Obstructions?	N/A			N/A
	Obstruction Type		Yes	Surface Condition? (G/P)	Good
			N/A	Curb Slope (%)	7.5

Remove & Replace Entire Ramp.

Total Cost: \$ 1600.00
