Access Compliance Report

Public Rights-of-Way

(Curb Ramps)

Intersection ID: 30561	Main Street: BUBBLING_BRANCH_LN	Cross Street: CIRCLEGREEN_DR	Location:	N
ADA ID: 32D9EFBCEF3B	Ramp Type: PerpDiag	Initial Pass/Fail: Fail	Overall Compliance: No	Severity Score: 37.5
Codes/Mitigation Info/Possible Solution		Field Measurements/Component Compliance

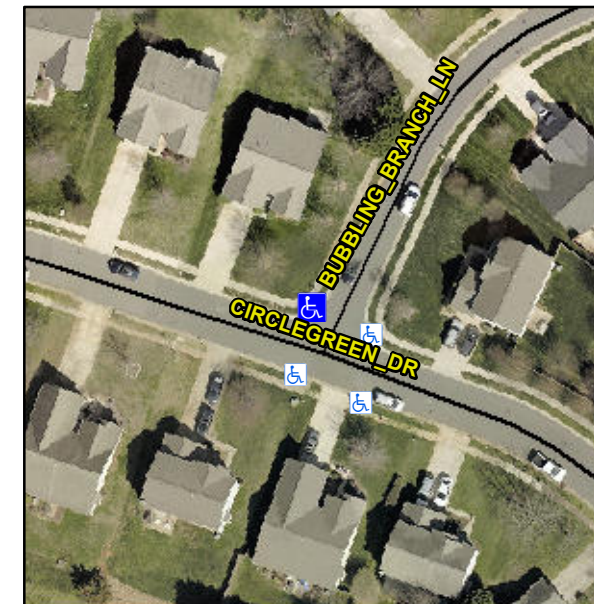
R304.2.2, R304.5.3

Compliance	Description	Data	Compliance	Description	Data
N/A	Ramp Length (in)	48.5	No	Ramp Slope (%)	9.6
Yes	Ramp Width (in)	48.0	No	Ramp XSlope (%)	10.7
N/A	Flare Type LT	N/A	N/A	Flare Type RT	N/A
N/A	Flare Slope LT (%)	N/A	N/A	Flare Slope RT (%)	N/A
N/A	Flare Traversable LT?	N/A	N/A	Flare Traversable RT?	N/A
N/A	Landing Length (in)	N/A	N/A	DWS Provided?	N/A
N/A	Landing Width (in)	N/A	N/A	DWS Contrast?	N/A
N/A	Landing Slope (%)	N/A	N/A	DWS Length (in)	N/A
N/A	Landing X Slope (%)	N/A	N/A	DWS Full Width?	N/A
N/A	Landing Curb? (Y/N)	N/A	N/A	DWS Offset (in)	N/A
N/A	Shared Landing?	N/A			
N/A	Gutter Ponding?	N/A	N/A	Gutter Slope (%)	N/A
N/A	Gutter Lip Ht (in)	N/A	N/A	Gutter X Slope (%)	N/A
N/A	Painted X Walk1?	No	N/A	Painted X Walk2?	No
	X Walk 1 Direction	To SW		X Walk 2 Direction	To SE
N/A	X Walk 1 Width (in)	N/A	N/A	X Walk 2 Width (in)	N/A
	X Walk 1 Slope (%)	3.3		X Walk 2 Slope (%)	5.7
	X Walk 1 X Slope (%)	8.2		X Walk 2 X Slope (%)	3.4

N/A	Ramp inside XWalk1?	N/A	N/A	Ramp inside XWalk2?	N/A
	Road Slope (%)	6.7	N/A	Clear Space?	N/A
	Road X Slope (%)	3.3	N/A	Clear Space to XWalk (in)	N/A
N/A	Any Obstructions?	N/A	N/A	Storm Grate/Utility Hazard?	N/A
	Obstruction Type			Storm Grate/Utility Type	
		N/A			N/A
			Yes	Surface Condition? (G/P)	Good

Remove & Replace Curb Ramp With Two New Directional Ramps or Equivalent.

Total Cost: \$ 3200.00
