Access Compliance Report Public Rights-of-Way (Curb Ramps)

Intersection ID: 29678Main Street:CAMERON_CREEK_DRCross Street:WEDDINGTON_RIDGE_LNLocation:SEADA ID: 32DB4596CFF0Ramp Type:BlendTrans1Initial Pass/Fail:PassOverall Compliance:NoSeverity Score:15

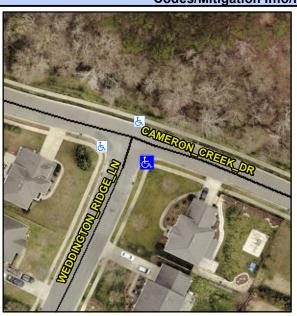
Not Found, R304.2.2-Perp, R304.3.2-Para, R305, R304.5.4

Compliance Description Data			Compliance Description		Data
N/A	Ramp Length (in)	47.0	Yes	BlendTrans Slope (%)	4.0
Yes	Ramp Width (in)	51.0	Yes	BlendTrans XSlope (%)	1.5
N/A	Flare Type LT	Sloped	N/A	Flare Type RT	Sloped
N/A	Flare Slope LT (%)	0.8	N/A	Flare Slope RT (%)	7.1
N/A	Flare Traversable LT?	No	N/A	Flare Traversable RT?	No
Yes	Landing Length (in)	48.0	No	DWS Provided?	No
Yes	Landing Width (in)	51.0	N/A	DWS Contrast?	No
No	Landing Slope (%)	2.8	N/A	DWS Length (in)	N/A
Yes	Landing X Slope (%)	0.5	N/A	DWS Full Width?	No
N/A	Landing Curb? (Y/N)	No	N/A	DWS Offset (in)	N/A
N/A	Shared Landing?	No			
Yes	Gutter Ponding?	No	No	Gutter Slope (%)	9.9
Yes	Gutter Lip Ht (in)	0.0	Yes	Gutter X Slope (%)	0.0
N/A	Painted X Walk1?	No	N/A	Painted X Walk2?	No
	X Walk 1 Direction	To N		X Walk 2 Direction	To NW
	X Walk 1 Width (in)	N/A		X Walk 2 Width (in)	N/A
	X Walk 1 Slope (%)	2.7		X Walk 2 Slope (%)	5.1
	X Walk 1 X Slope (%)	2.1		X Walk 2 X Slope (%)	2.2

N/A	Ramp inside XWalk1?	N/A	N/A	Ramp inside XWalk2?	N/A
	Road Slope (%)	0.0		Clear Space?	Yes
	Road X Slope (%)	2.8	N/A	Clear Space to XWalk (in)	N/A
Yes	Any Obstructions?	No	Yes	Storm Grate/Utility Hazard?	No
	Obstruction Type			Storm Grate/Utility Type	
		N/A			N/A
			Yes	Surface Condition? (G/P)	Good
à-			No	Curb Slope (%)	13.3

Remove & Replace Curb Ramp With Two New Directional Ramps or Equivalent. Remove & Replace Gutter.
