Access Compliance Report

Public Rights-of-Way

(Curb Ramps)

Intersection ID: 17250	Main Street: CROYDON_RD	Cross Street: QUEENS_RD_WEST	Location: N
ADA ID: 32DD16EC9584	Ramp Type: Directional1	Initial Pass/Fail: Fail	Overall Compliance: No
		Severity Score: 12.5

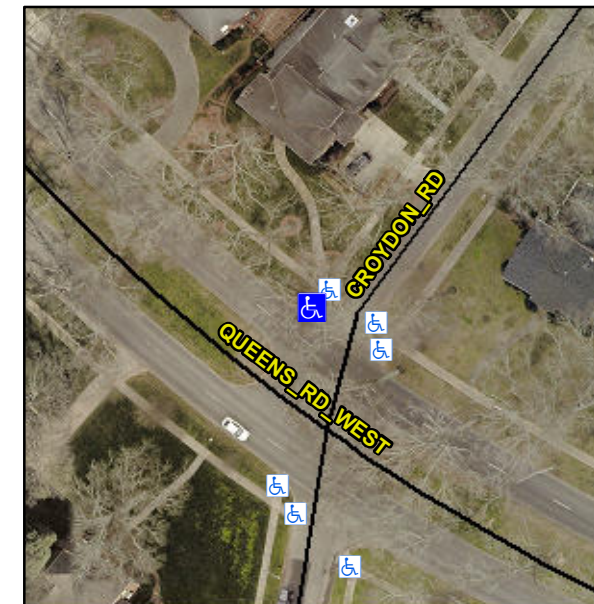
Compliance	Description	Data	Compliance	Description	Data
N/A	Ramp Length (in)	47.0	N/A	Grade Break?	N/A
Yes	Ramp Width (in)	71.0	N/A	Grade Break Slope (%)	0.0
Yes	Ramp Slope (%)	8.2	N/A	Grade Break XSlope (%)	0.0
No	Ramp XSlope (%)	5.3			
N/A	Flare Type LT	N/A	N/A	Flare Type RT	N/A
N/A	Flare Slope LT (%)	N/A	N/A	Flare Slope RT (%)	0.0
N/A	Flare Traversable LT?	N/A	N/A	Flare Traversable RT?	N/A
N/A	Landing Length (in)	0.0	N/A	DWS Provided?	N/A
N/A	Landing Width (in)	0.0	N/A	DWS Contrast?	N/A
N/A	Landing Slope (%)	0.0	N/A	DWS Length (in)	N/A
N/A	Landing X Slope (%)	0.0	N/A	DWS Full Width?	N/A
N/A	Landing Curb? (Y/N)	N/A	N/A	DWS Offset LT (in)	N/A
N/A	Shared Landing?	N/A	N/A	DWS Offset RT (in)	N/A
N/A	Gutter Ponding?	0.0	N/A	Gutter Slope (%)	N/A
N/A	Gutter Lip Ht (in)	0.0	N/A	Gutter X Slope (%)	N/A
N/A	Painted X Walk1?	No		Road Slope (%)	3.6
	X Walk 1 Direction	To SW		Road X Slope (%)	2.3
	X Walk 1 Width (in)	N/A		Clear Space?	N/A

X Walk 1 Slope (%)	3.6	N/A	Clear Space to XWalk (in)	N/A
	X Walk 1 X Slope (%)	2.3	N/A	Storm Grate/Utility Hazard?	N/A
N/A	Ramp inside XWalk1?	N/A		Storm Grate/Utility Type	
N/A	Any Obstructions?	N/A			N/A
	Obstruction Type		Yes	Surface Condition? (G/P)	Good
			N/A	Curb Slope (%)	16.9

Remove & Replace Entire Ramp.

R304.5.3

\$ 1600.00
