# Access Compliance Report

## Public Rights-of-Way

### (Curb Ramps)

| Intersection ID: 12521 | Main Street: BELVEDERE_AV | Cross Street: CHATHAM_AV | Location: NE |

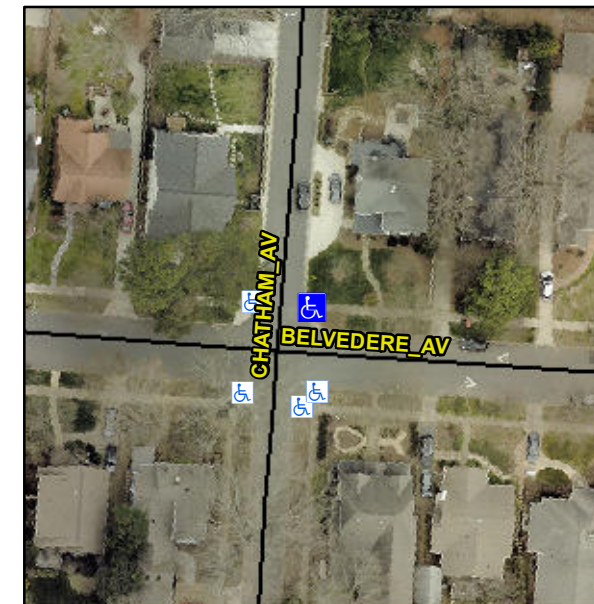
**Not Found, R304.5.3, R305**

| Compliance | Description | Data | Compliance | Description | Data |
|---|---|---|---|---|---|
| Yes | Landing Length (in) | 60.0 | No | DWS Provided? | No |
| No | Landing X Slope (%) | 3.2 | N/A | DWS Full Width? | No |
| Yes | Gutter Lip Ht (in) | 0.0 | No | Gutter X Slope (%) | 3.1 |

**Remove & Replace Curb Ramp With Two New Directional Ramps or Equivalent. Remove & Replace Gutter.**
