Access Compliance Report

Public Rights-of-Way

(Curb Ramps)

Intersection ID: 53390	Main Street: KELBURN_LN	Cross Street: AGNEW_DR	Location: NW
ADA ID: 32DF63A3E716	Ramp Type: BlendTrans1	Initial Pass/Fail: Fail	Overall Compliance: No
Severity Score: 1.25			
Codes/Mitigation Info/Possible Solution		Field Measurements/Component Compliance

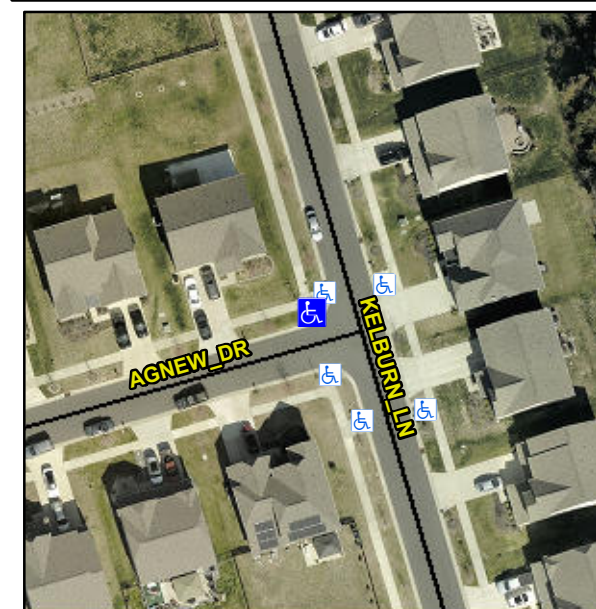
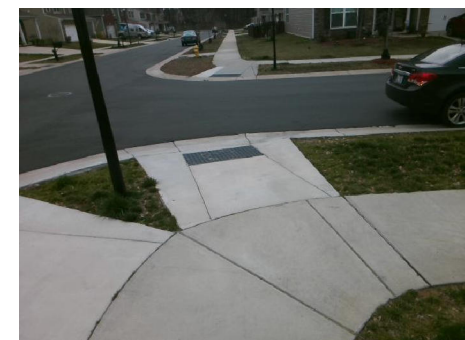
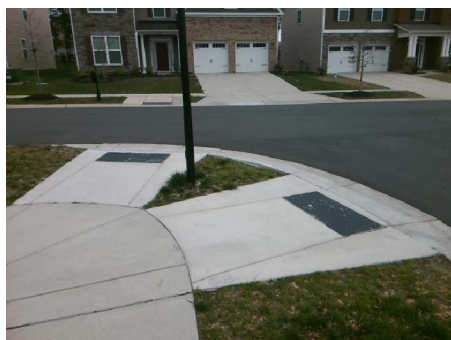
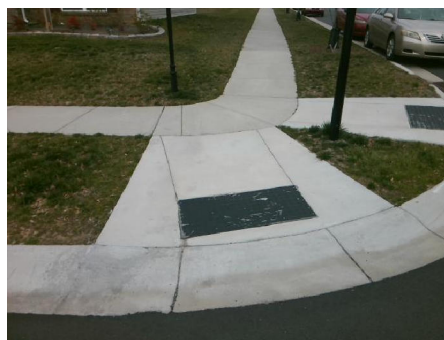
Compliance	Description	Data	Compliance	Description	Data
N/A	Ramp Length (in)	97.0	Yes	BlendTrans Slope (%)	2.6
Yes	Ramp Width (in)	48.0	No	BlendTrans XSlope (%)	4.5
N/A	Flare Type LT	N/A	N/A	Flare Type RT	N/A
N/A	Flare Slope LT (%)	N/A	N/A	Flare Slope RT (%)	N/A
N/A	Flare Traversable LT?	N/A	N/A	Flare Traversable RT?	N/A
N/A	Landing Length (in)	N/A	N/A	DWS Provided?	N/A
N/A	Landing Width (in)	N/A	N/A	DWS Contrast?	N/A
N/A	Landing Slope (%)	N/A	N/A	DWS Length (in)	N/A
N/A	Landing X Slope (%)	N/A	N/A	DWS Full Width?	N/A
N/A	Landing Curb? (Y/N)	N/A	N/A	DWS Offset (in)	N/A
N/A	Shared Landing?	N/A			
N/A	Gutter Ponding?	N/A	N/A	Gutter Slope (%)	N/A
N/A	Gutter Lip Ht (in)	N/A	N/A	Gutter X Slope (%)	N/A
N/A	Painted X Walk1?	No	N/A	Painted X Walk2?	N/A
	X Walk 1 Direction	To SE		X Walk 2 Direction	N/A
	X Walk 1 Width (in)	N/A		X Walk 2 Width (in)	N/A
	X Walk 1 Slope (%)	2.7		X Walk 2 Slope (%)	N/A
	X Walk 1 X Slope (%)	4.4		X Walk 2 X Slope (%)	N/A

N/A	Ramp inside XWalk1?	N/A	N/A	Ramp inside XWalk2?	N/A
	Road Slope (%)	4.4		Clear Space?	N/A
	Road X Slope (%)	2.7	N/A	Clear Space to XWalk (in)	N/A
N/A	Any Obstructions?	N/A	N/A	Storm Grate/Utility Hazard?	N/A
	Obstruction Type			Storm Grate/Utility Type	
		N/A			N/A
			Yes	Surface Condition? (G/P)	Good
			N/A	Curb Slope (%)	4.4

Possible Solutions:

Remove & Replace Curb Ramp With Two New Directional Ramps or Equivalent.

R304.5.3
