# Access Compliance Report

## Public Rights-of-Way

### (Curb Ramps)

| Intersection ID: 10022967 | Main Street: CEDAR_WALK_LN | Cross Street: N/A | Location: | N |

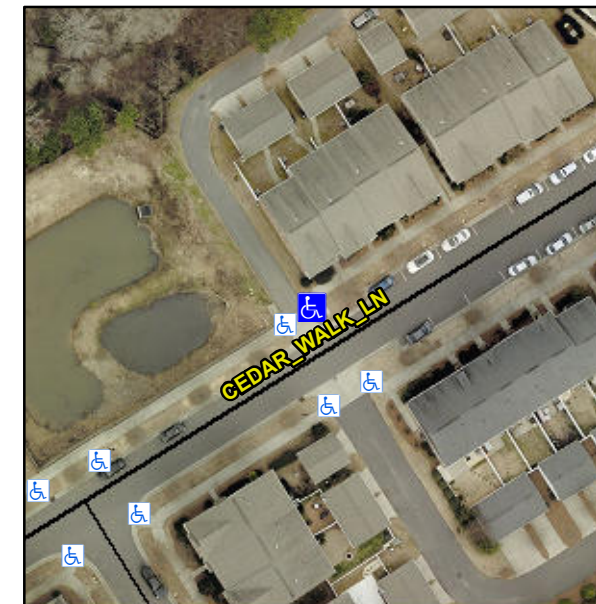
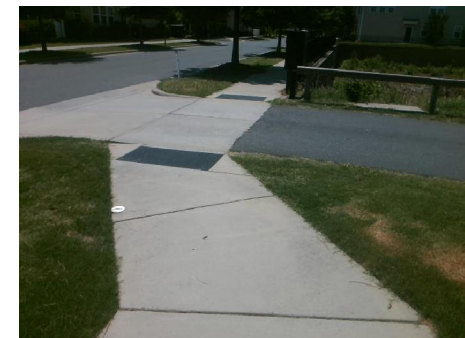
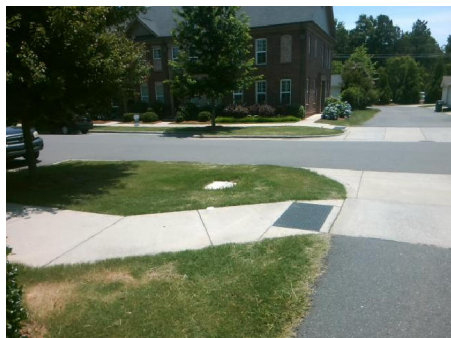
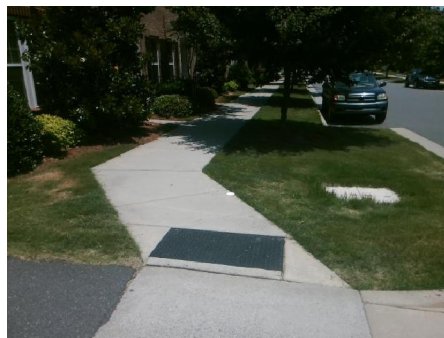
| ADA ID: 32E2A7BADA85 | Ramp Type: BlendTrans1 | Initial Pass/Fail: Pass | Overall Compliance: No | Severity Score: 0 |

| Compliance | Description | Data | Compliance | Description | Data |
|---|---|---|---|---|---|
| No | Landing Length (in) | 41.5 | Yes | DWS Provided? | Yes |
| N/A | Landing Curb? (Y/N) | No | No | DWS Offset (in) | 4.5 |

**Remove & Replace Curb Ramp With Two New Directional Ramps or Equivalent.**

**R304.2.1, R305.2**

Total Cost: \$ 3200.00
