# Access Compliance Report

## Public Rights-of-Way

### (Curb Ramps)

Intersection ID: 14086	Main Street: BALDWIN_AV	Cross Street: E_3RD_ST	Location: SE
ADA ID: 32E2E42DE68B	Ramp Type: Perp	Initial Pass/Fail: Fail	Overall Compliance: No
Severity Score: 31.25			
Codes/Mitigation Info/Possible Solution		Field Measurements/Component Compliance

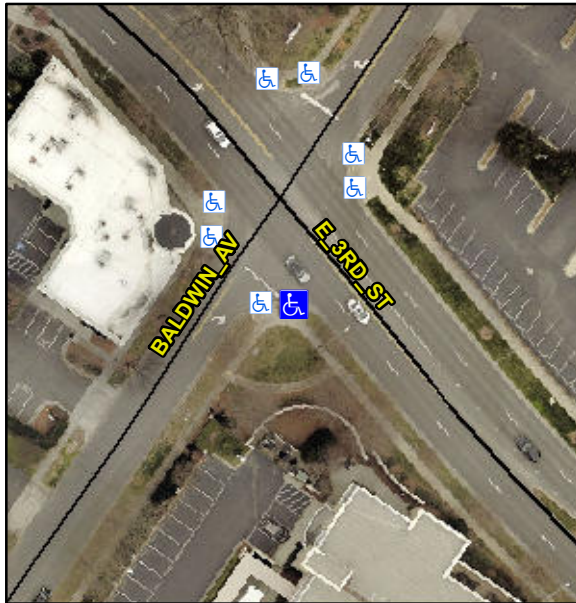
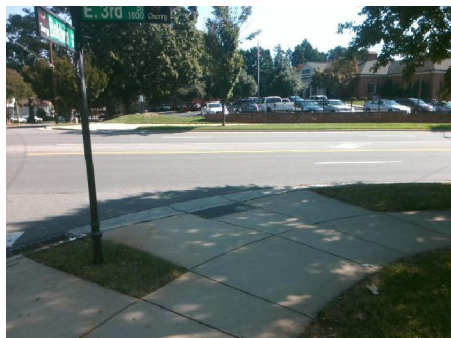
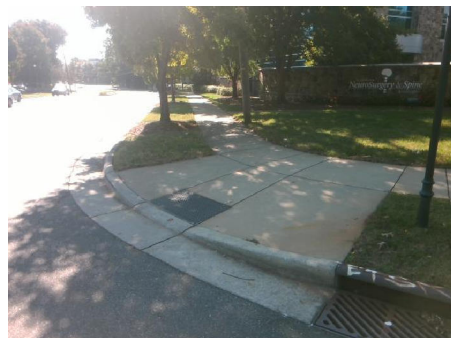
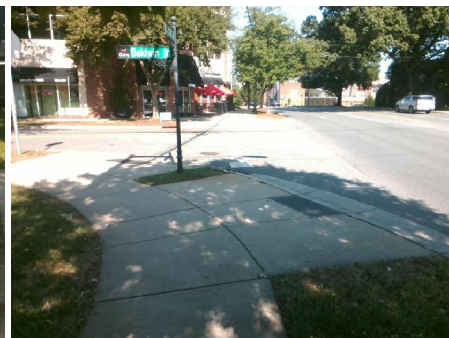
**Not Found, R304.5.1, R304.2.2, R304.5.3**

Compliance	Description	Data	Compliance	Description	Data
N/A	Ramp Length (in)	84.0	No	Ramp Slope (%)	8.7
No	Ramp Width (in)	35.0	No	Ramp XSlope (%)	2.1
N/A	Flare Type LT	N/A	N/A	Flare Type RT	N/A
N/A	Flare Slope LT (%)	N/A	N/A	Flare Slope RT (%)	N/A
N/A	Flare Traversable LT?	N/A	N/A	Flare Traversable RT?	N/A
N/A	Landing Length (in)	N/A	N/A	DWS Provided?	N/A
N/A	Landing Width (in)	N/A	N/A	DWS Contrast?	N/A
N/A	Landing Slope (%)	N/A	N/A	DWS Length (in)	N/A
N/A	Landing X Slope (%)	N/A	N/A	DWS Full Width?	N/A
N/A	Landing Curb? (Y/N)	N/A	N/A	DWS Offset (in)	N/A
N/A	Shared Landing?	N/A			
N/A	Gutter Ponding?	N/A	N/A	Gutter Slope (%)	N/A
N/A	Gutter Lip Ht (in)	N/A	N/A	Gutter X Slope (%)	N/A
N/A	Painted X Walk1?	No	N/A	Painted X Walk2?	N/A
	X Walk 1 Direction	To NE		X Walk 2 Direction	N/A
N/A	X Walk 1 Width (in)	N/A	N/A	X Walk 2 Width (in)	N/A
	X Walk 1 Slope (%)	4.0		X Walk 2 Slope (%)	N/A
	X Walk 1 X Slope (%)	1.9		X Walk 2 X Slope (%)	N/A

N/A	Ramp inside XWalk1?	N/A	N/A	Ramp inside XWalk2?	N/A
	Road Slope (%)	N/A	N/A	Clear Space?	N/A
	Road X Slope (%)	N/A	N/A	Clear Space to XWalk (in)	N/A
N/A	Any Obstructions?	N/A	N/A	Storm Grate/Utility Hazard?	N/A
	Obstruction Type			Storm Grate/Utility Type	
		N/A			N/A
			Yes	Surface Condition? (G/P)	Good

**Remove & Replace Entire Ramp.**
