Access Compliance Report

Public Rights-of-Way

(Curb Ramps)

Intersection ID: 11202	Main Street: N_TRYON_ST	Cross Street: W_15TH_ST	Location: N
ADA ID: 32E4420EB3DC	Ramp Type: Perp	Initial Pass/Fail: Fail	Overall Compliance: No
Severity Score: 22.5			
Codes/Mitigation Info/Possible Solution		Field Measurements/Component Compliance

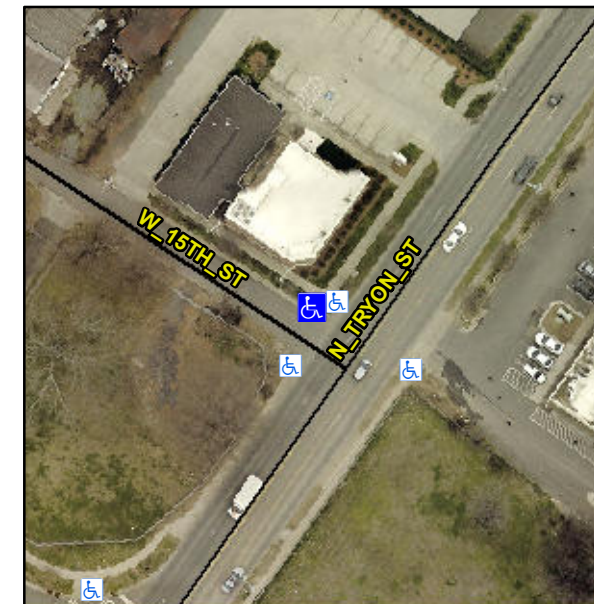
Compliance	Description	Data	Compliance	Description	Data
N/A	Ramp Length (in)	59.0	No	Ramp Slope (%)	11.8
No	Ramp Width (in)	46.0	No	Ramp XSlope (%)	3.1
N/A	Flare Type LT	N/A	N/A	Flare Type RT	N/A
N/A	Flare Slope LT (%)	N/A	N/A	Flare Slope RT (%)	N/A
N/A	Flare Traversable LT?	N/A	N/A	Flare Traversable RT?	N/A
N/A	Landing Length (in)	N/A	N/A	DWS Provided?	N/A
N/A	Landing Width (in)	N/A	N/A	DWS Contrast?	N/A
N/A	Landing Slope (%)	N/A	N/A	DWS Length (in)	N/A
N/A	Landing X Slope (%)	N/A	N/A	DWS Full Width?	N/A
N/A	Landing Curb? (Y/N)	N/A	N/A	DWS Offset (in)	N/A
N/A	Shared Landing?	N/A			
N/A	Gutter Ponding?	N/A	N/A	Gutter Slope (%)	N/A
N/A	Gutter Lip Ht (in)	N/A	N/A	Gutter X Slope (%)	N/A
N/A	Painted X Walk1?	No	N/A	Painted X Walk2?	N/A
	X Walk 1 Direction	To SW		X Walk 2 Direction	N/A
N/A	X Walk 1 Width (in)	N/A	N/A	X Walk 2 Width (in)	N/A
	X Walk 1 Slope (%)	1.1		X Walk 2 Slope (%)	N/A
	X Walk 1 X Slope (%)	1.6		X Walk 2 X Slope (%)	N/A

N/A	Ramp inside XWalk1?	N/A	N/A	Ramp inside XWalk2?	N/A
	Road Slope (%)	N/A	N/A	Clear Space?	N/A
	Road X Slope (%)	N/A	N/A	Clear Space to XWalk (in)	N/A
N/A	Any Obstructions?	N/A	N/A	Storm Grate/Utility Hazard?	N/A
	Obstruction Type			Storm Grate/Utility Type	
		N/A			N/A
			Yes	Surface Condition? (G/P)	Good

Possible Solutions:

Remove & Replace Entire Ramp.

R304.5.1, R304.2.2, R304.5.3
