Access Compliance Report Public Rights-of-Way (Curb Ramps)

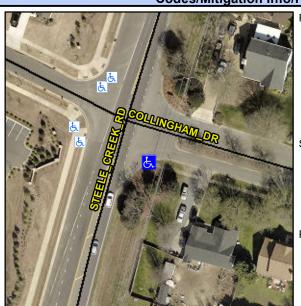
N/A
		N/A
		N/A
		N/A
\$	1600.00

Field Measurements/Component Compliance								
Compli	Data	Comp	liance Description	Data				
N/A	Ramp Length (in)	34.0	N/A	Grade Break?	N/A			
Yes	Ramp Width (in)	48.0	N/A	Grade Break Slope (%)	0.0			
No	Ramp Slope (%)	10.0	N/A	Grade Break XSlope (%)	0.0			
Yes	Ramp XSlope (%)	0.1						
N/A	Flare Type LT	N/A	N/A	Flare Type RT	N/A			
N/A	Flare Slope LT (%)	N/A	N/A	Flare Slope RT (%)	0.0			
N/A	Flare Traversable LT?	N/A	N/A	Flare Traversable RT?	N/A			
N/A	Landing Length (in)	0.0	N/A	DWS Provided?	N/A			
N/A	Landing Width (in)	0.0	N/A	DWS Contrast?	N/A			
N/A	Landing Slope (%)	0.0	N/A	DWS Length (in)	N/A			
N/A	Landing X Slope (%)	0.0	N/A	DWS Full Width?	N/A			
N/A	Landing Curb? (Y/N)	N/A	N/A	DWS Offset LT (in)	N/A			
N/A	Shared Landing?	N/A	N/A	DWS Offset RT (in)	N/A			
N/A	Gutter Ponding?	0.0	N/A	Gutter Slope (%)	N/A			
N/A	Gutter Lip Ht (in)	0.0	N/A	Gutter X Slope (%)	N/A			
N/A	Painted X Walk1?	No		Road Slope (%)	4.8

STEELE CREEK RD Street 1 Name None Stop Condition-Street 1 Street 2 Name N/A Stop Condition-Street 2 N/A

3	Possible Solutions:				
	Remove & Replace Entire Ramp.				
76	Surveyor Notes:				
The state of the s	N/A				
-	PROW/ADA:				
The State of	R304.2.2
