Access Compliance Report

Public Rights-of-Way

(Curb Ramps)

Intersection ID: 22182	Main Street: ENGLAND_ST	Cross Street: STOCKHOLM_CT	Location: SE
ADA ID: 32E611C6C2AA	Ramp Type: PerpDiag	Initial Pass/Fail: Fail	Overall Compliance: No
		Severity Score: 25

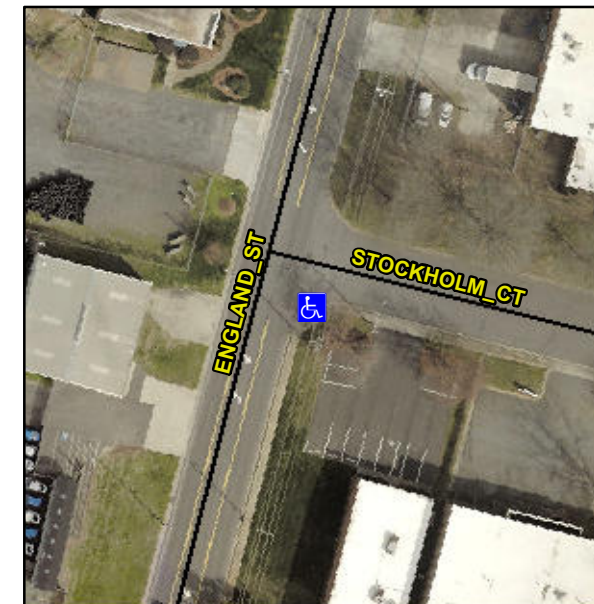
Not Found, R304.2.2, R304.5.3

Compliance	Description	Data	Compliance	Description	Data
N/A	Ramp Length (in)	60.0	No	Ramp Slope (%)	9.5
Yes	Ramp Width (in)	48.0	No	Ramp XSlope (%)	6.4
N/A	Flare Type LT	N/A	N/A	Flare Type RT	N/A
N/A	Flare Slope LT (%)	N/A	N/A	Flare Slope RT (%)	N/A
N/A	Flare Traversable LT?	N/A	N/A	Flare Traversable RT?	N/A
N/A	Landing Length (in)	N/A	N/A	DWS Provided?	N/A
N/A	Landing Width (in)	N/A	N/A	DWS Contrast?	N/A
N/A	Landing Slope (%)	N/A	N/A	DWS Length (in)	N/A
N/A	Landing X Slope (%)	N/A	N/A	DWS Full Width?	N/A
N/A	Landing Curb? (Y/N)	N/A	N/A	DWS Offset (in)	N/A
N/A	Shared Landing?	N/A			
N/A	Gutter Ponding?	N/A	N/A	Gutter Slope (%)	N/A
N/A	Gutter Lip Ht (in)	N/A	N/A	Gutter X Slope (%)	N/A
N/A	Painted X Walk1?	No	N/A	Painted X Walk2?	No
	X Walk 1 Direction	To NE		X Walk 2 Direction	To NW
N/A	X Walk 1 Width (in)	N/A	N/A	X Walk 2 Width (in)	N/A
	X Walk 1 Slope (%)	5.1		X Walk 2 Slope (%)	4.4
	X Walk 1 X Slope (%)	0.6		X Walk 2 X Slope (%)	3.0

N/A	Ramp inside XWalk1?	N/A	N/A	Ramp inside XWalk2?	N/A
	Road Slope (%)	1.4	N/A	Clear Space?	N/A
	Road X Slope (%)	5.5	N/A	Clear Space to XWalk (in)	N/A
N/A	Any Obstructions?	N/A	N/A	Storm Grate/Utility Hazard?	N/A
	Obstruction Type			Storm Grate/Utility Type	
		N/A			N/A
			Yes	Surface Condition? (G/P)	Good

Remove & Replace Curb Ramp With Two New Directional Ramps or Equivalent.

Total Cost: \$ 3200.00
