Access Compliance Report

Public Rights-of-Way

(Curb Ramps)

Intersection ID: 29980	Main Street: LONG_HILL_DR	Cross Street: WINDING_RIVER_DR	Location: NW
ADA ID: 32E745FC46F4	Ramp Type: BlendTrans1	Initial Pass/Fail: Fail	Overall Compliance: No
		Severity Score: 8.75

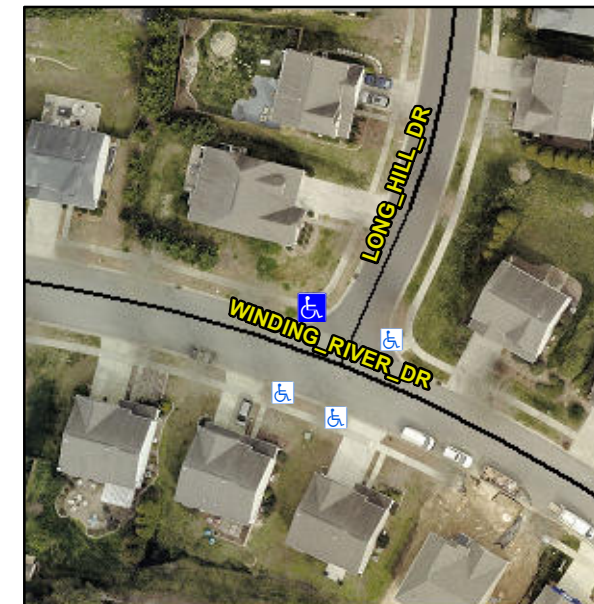
Compliance	Description	Data	Compliance	Description	Data
N/A	Ramp Length (in)	73.0	Yes	BlendTrans Slope (%)	4.2
No	Ramp Width (in)	47.5	Yes	BlendTrans XSlope (%)	1.3
N/A	Flare Type LT	N/A	N/A	Flare Type RT	N/A
N/A	Flare Slope LT (%)	N/A	N/A	Flare Slope RT (%)	N/A
N/A	Flare Traversable LT?	N/A	N/A	Flare Traversable RT?	N/A
N/A	Landing Length (in)	N/A	N/A	DWS Provided?	N/A
N/A	Landing Width (in)	N/A	N/A	DWS Contrast?	N/A
N/A	Landing Slope (%)	N/A	N/A	DWS Length (in)	N/A
N/A	Landing X Slope (%)	N/A	N/A	DWS Full Width?	N/A
N/A	Landing Curb? (Y/N)	N/A	N/A	DWS Offset (in)	N/A
N/A	Shared Landing?	N/A			
N/A	Gutter Ponding?	N/A	N/A	Gutter Slope (%)	N/A
N/A	Gutter Lip Ht (in)	N/A	N/A	Gutter X Slope (%)	N/A
N/A	Painted X Walk1?	No	N/A	Painted X Walk2?	No
	X Walk 1 Direction	To S		X Walk 2 Direction	To SE
	X Walk 1 Width (in)	N/A		X Walk 2 Width (in)	N/A
	X Walk 1 Slope (%)	1.3		X Walk 2 Slope (%)	3.2
	X Walk 1 X Slope (%)	3.5		X Walk 2 X Slope (%)	4.4

N/A	Ramp inside XWalk1?	N/A	N/A	Ramp inside XWalk2?	N/A
	Road Slope (%)	0.0		Clear Space?	N/A
	Road X Slope (%)	4.3	N/A	Clear Space to XWalk (in)	N/A
N/A	Any Obstructions?	N/A	N/A	Storm Grate/Utility Hazard?	N/A
	Obstruction Type			Storm Grate/Utility Type	
		N/A			N/A
			Yes	Surface Condition? (G/P)	Good
			N/A	Curb Slope (%)	3.0

Possible Solutions:

Remove & Replace Curb Ramp With Two New Directional Ramps or Equivalent.

R304.5.1
