# Access Compliance Report

## Public Rights-of-Way

### (Curb Ramps)

Intersection ID: 9627	Main Street: BLENDWOOD_DR	Cross Street: THE_PLAZA	Location: SW
ADA ID: 32FA0E43A888	Ramp Type: Perp	Initial Pass/Fail: Fail	Overall Compliance: No
Severity Score: 46.25			
Codes/Mitigation Info/Possible Solution		Field Measurements/Component Compliance

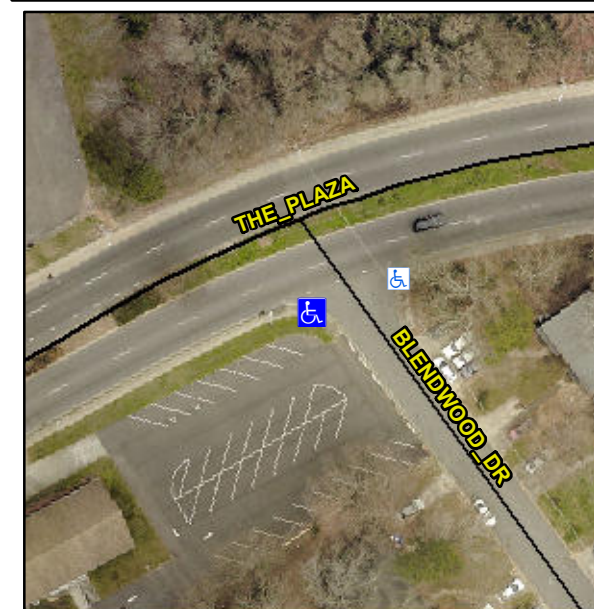
**Not Found, R304.5.1, R304.2.2, R304.5.3**

Compliance	Description	Data	Compliance	Description	Data
N/A	Ramp Length (in)	59.0	No	Ramp Slope (%)	9.1
No	Ramp Width (in)	40.0	No	Ramp XSlope (%)	10.0
N/A	Flare Type LT	N/A	N/A	Flare Type RT	N/A
N/A	Flare Slope LT (%)	N/A	N/A	Flare Slope RT (%)	N/A
N/A	Flare Traversable LT?	N/A	N/A	Flare Traversable RT?	N/A
N/A	Landing Length (in)	N/A	N/A	DWS Provided?	N/A
N/A	Landing Width (in)	N/A	N/A	DWS Contrast?	N/A
N/A	Landing Slope (%)	N/A	N/A	DWS Length (in)	N/A
N/A	Landing X Slope (%)	N/A	N/A	DWS Full Width?	N/A
N/A	Landing Curb? (Y/N)	N/A	N/A	DWS Offset (in)	N/A
N/A	Shared Landing?	N/A			
N/A	Gutter Ponding?	N/A	N/A	Gutter Slope (%)	N/A
N/A	Gutter Lip Ht (in)	N/A	N/A	Gutter X Slope (%)	N/A
N/A	Painted X Walk1?	No	N/A	Painted X Walk2?	N/A
	X Walk 1 Direction	To NE		X Walk 2 Direction	N/A
N/A	X Walk 1 Width (in)	N/A	N/A	X Walk 2 Width (in)	N/A
	X Walk 1 Slope (%)	2.6		X Walk 2 Slope (%)	N/A
	X Walk 1 X Slope (%)	8.9		X Walk 2 X Slope (%)	N/A

N/A	Ramp inside XWalk1?	N/A	N/A	Ramp inside XWalk2?	N/A
	Road Slope (%)	N/A	N/A	Clear Space?	N/A
	Road X Slope (%)	N/A	N/A	Clear Space to XWalk (in)	N/A
N/A	Any Obstructions?	N/A	N/A	Storm Grate/Utility Hazard?	N/A
	Obstruction Type			Storm Grate/Utility Type	
		N/A			N/A
			Yes	Surface Condition? (G/P)	Good

**Remove & Replace Entire Ramp.**
