Access Compliance Report

Public Rights-of-Way

(Curb Ramps)

Intersection ID: 19449	Main Street: PRESTON_LN	Cross Street: SARDIS_RD	Location: S
ADA ID: 32FAE6D60253	Ramp Type: PerpDiag	Initial Pass/Fail: Fail	Overall Compliance: No
			Severity Score: 26.25

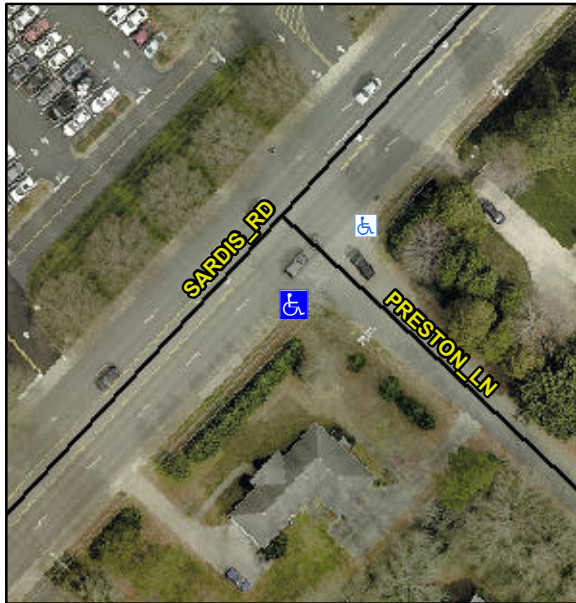
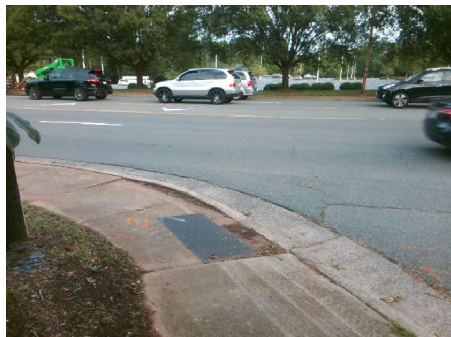
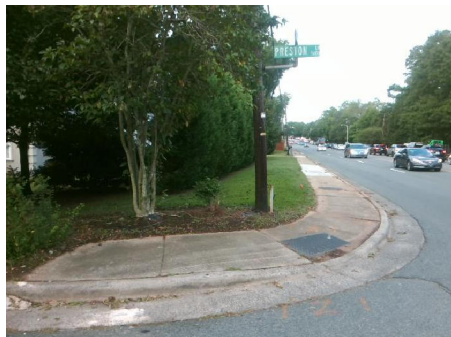
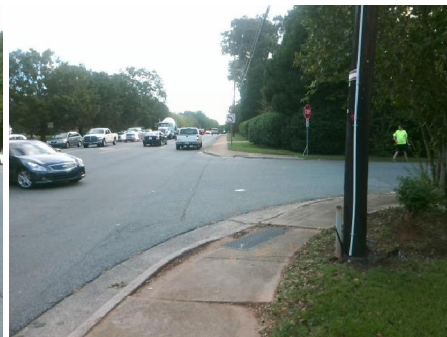
Not Found, R304.2.2, R304.5.3

Compliance	Description	Data	Compliance	Description	Data
N/A	Ramp Length (in)	59.0	No	Ramp Slope (%)	12.2
Yes	Ramp Width (in)	48.0	No	Ramp XSlope (%)	3.4
N/A	Flare Type LT	N/A	N/A	Flare Type RT	N/A
N/A	Flare Slope LT (%)	N/A	N/A	Flare Slope RT (%)	N/A
N/A	Flare Traversable LT?	N/A	N/A	Flare Traversable RT?	N/A
N/A	Landing Length (in)	N/A	N/A	DWS Provided?	N/A
N/A	Landing Width (in)	N/A	N/A	DWS Contrast?	N/A
N/A	Landing Slope (%)	N/A	N/A	DWS Length (in)	N/A
N/A	Landing X Slope (%)	N/A	N/A	DWS Full Width?	N/A
N/A	Landing Curb? (Y/N)	N/A	N/A	DWS Offset (in)	N/A
N/A	Shared Landing?	N/A			
N/A	Gutter Ponding?	N/A	N/A	Gutter Slope (%)	N/A
N/A	Gutter Lip Ht (in)	N/A	N/A	Gutter X Slope (%)	N/A
N/A	Painted X Walk1?	No	N/A	Painted X Walk2?	No
	X Walk 1 Direction	To NE		X Walk 2 Direction	To NW
N/A	X Walk 1 Width (in)	N/A	N/A	X Walk 2 Width (in)	N/A
	X Walk 1 Slope (%)	3.2		X Walk 2 Slope (%)	1.8
	X Walk 1 X Slope (%)	0.3		X Walk 2 X Slope (%)	2.4

N/A	Ramp inside XWalk1?	N/A	N/A	Ramp inside XWalk2?	N/A
	Road Slope (%)	0.7	N/A	Clear Space?	N/A
	Road X Slope (%)	3.7	N/A	Clear Space to XWalk (in)	N/A
N/A	Any Obstructions?	N/A	N/A	Storm Grate/Utility Hazard?	N/A
	Obstruction Type			Storm Grate/Utility Type	
		N/A			N/A
			Yes	Surface Condition? (G/P)	Good

Remove & Replace Curb Ramp With Two New Directional Ramps or Equivalent.
