## Access Compliance Report Public Rights-of-Way (Curb Ramps)

Intersection ID: 1001290 Main Street: DAVID\_TAYLOR\_DR Cross Street: CLAUDE\_FREEMAN\_DR Location: SE

ADA ID: 32FFC459E1AC Ramp Type: Perp Initial Pass/Fail: Fail Overall Compliance: No Severity Score: 46.25

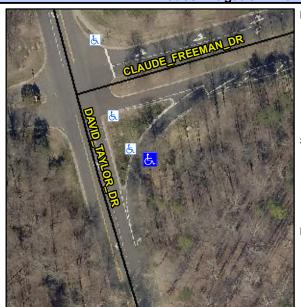
Compl	iance Description	Data	Compli	iance	Description	Data
N/A	Ramp Length (in)	60.5	No	Ram	Slope (%)	13.6
No	Ramp Width (in)	47.5	No	Ram	XSlope (%)	6.1
N/A	Flare Type LT	N/A	N/A	Flare	Type RT	N/A
N/A	Flare Slope LT (%)	N/A	N/A	Flare	Slope RT (%)	N/A
N/A	Flare Traversable LT?	N/A	N/A	Flare	Traversable RT?	N/A
N/A	Landing Length (in)	N/A	N/A	DWS	Provided?	N/A
N/A	Landing Width (in)	N/A	N/A	DWS	Contrast?	N/A
N/A	Landing Slope (%)	N/A	N/A	DWS	Length (in)	N/A
N/A	Landing X Slope (%)	N/A	N/A	DWS	Full Width?	N/A
N/A	Landing Curb? (Y/N)	N/A	N/A	DWS	Offset (in)	N/A
N/A	Shared Landing?	N/A				
N/A	Gutter Ponding?	N/A	N/A	Gutte	er Slope (%)	N/A
N/A	Gutter Lip Ht (in)	N/A	N/A	Gutte	er X Slope (%)	N/A
N/A	Painted X Walk1?	No	N/A	Paint	ed X Walk2?	N/A
	X Walk 1 Direction	To NW		X Wa	lk 2 Direction	N/A
N/A	X Walk 1 Width (in)	N/A	N/A	X Wa	lk 2 Width (in)	N/A
	X Walk 1 Slope (%)	1.8		X Wa	lk 2 Slope (%)	N/A
	X Walk 1 X Slope (%)	8.5		X Wa	lk 2 X Slope (%)	N/A

N/A	Ramp inside XWalk1?	N/A	N/A	Ram	o inside XWalk2?	N/A
	Road Slope (%)	N/A	N/A	Clear	Space?	N/A
	Road X Slope (%)	N/A	N/A	Clear	Space to XWalk (in)	N/A
N/A	Any Obstructions?	N/A	N/A	Storn	n Grate/Utility Hazard?	N/A
	Obstruction Type			Storn	n Grate/Utility Type	
		N/A				N/A
			Yes	Surfa	ce Condition? (G/P)	Good

Possible Solutions:

Remove & Replace Entire Ramp.

R304.5.1, R304.2.2, R304.5.3

1850.00
