# Access Compliance Report

## Public Rights-of-Way

### (Curb Ramps)

Intersection ID: N/A	Main Street: ARCHDALE DR	Cross Street: NATIONS_FORD_DR	Location: SE
ADA ID: 330C5E6D38CC	Ramp Type: PerpDiag	Initial Pass/Fail: Fail	Overall Compliance: No
Codes/Mitigation Info/Possible Solution		Field Measurements/Component Compliance

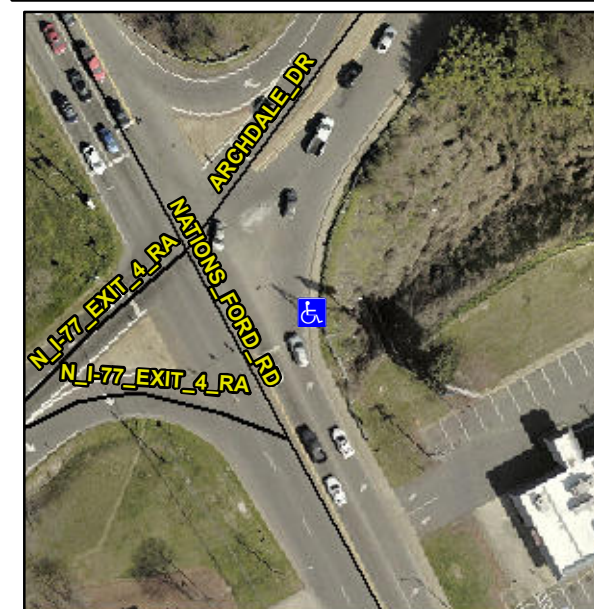
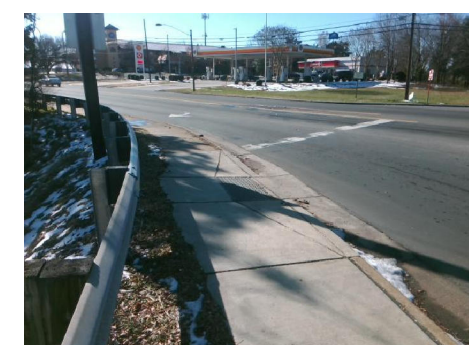
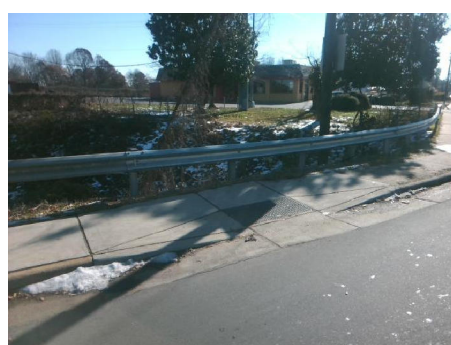
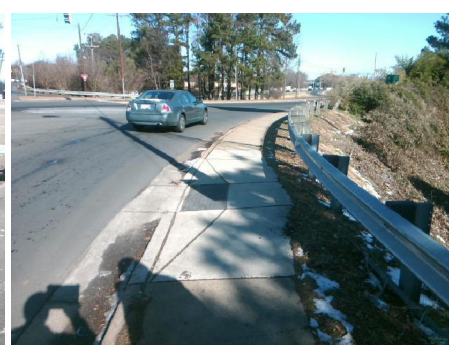
**Not Found, R304.5.1, R304.2.2**

Compliance	Description	Data	Compliance	Description	Data
N/A	Ramp Length (in)	62.0	No	Ramp Slope (%)	8.6
No	Ramp Width (in)	47.0	Yes	Ramp XSlope (%)	0.3
N/A	Flare Type LT	N/A	N/A	Flare Type RT	N/A
N/A	Flare Slope LT (%)	N/A	N/A	Flare Slope RT (%)	N/A
N/A	Flare Traversable LT?	N/A	N/A	Flare Traversable RT?	N/A
N/A	Landing Length (in)	N/A	N/A	DWS Provided?	N/A
N/A	Landing Width (in)	N/A	N/A	DWS Contrast?	N/A
N/A	Landing Slope (%)	N/A	N/A	DWS Length (in)	N/A
N/A	Landing X Slope (%)	N/A	N/A	DWS Full Width?	N/A
N/A	Landing Curb? (Y/N)	N/A	N/A	DWS Offset (in)	N/A
N/A	Shared Landing?	N/A			
N/A	Gutter Ponding?	N/A	N/A	Gutter Slope (%)	N/A
N/A	Gutter Lip Ht (in)	N/A	N/A	Gutter X Slope (%)	N/A
N/A	Painted X Walk1?	No	N/A	Painted X Walk2?	No
	X Walk 1 Direction	To N		X Walk 2 Direction	To W
N/A	X Walk 1 Width (in)	N/A	N/A	X Walk 2 Width (in)	N/A
	X Walk 1 Slope (%)	0.2		X Walk 2 Slope (%)	0.8
	X Walk 1 X Slope (%)	0.9		X Walk 2 X Slope (%)	0.3

N/A	Ramp inside XWalk1?	N/A	N/A	Ramp inside XWalk2?	N/A
	Road Slope (%)	0.2	N/A	Clear Space?	N/A
	Road X Slope (%)	1.3	N/A	Clear Space to XWalk (in)	N/A
N/A	Any Obstructions?	N/A	N/A	Storm Grate/Utility Hazard?	N/A
	Obstruction Type			Storm Grate/Utility Type	
		N/A			N/A
		Yes		Surface Condition? (G/P)	Good

**Remove & Replace Curb Ramp With Two New Directional Ramps or Equivalent.**

Total Cost: \$ 3200.00
