Access Compliance Report

Public Rights-of-Way

(Curb Ramps)

Intersection ID: 53882	Main Street: PAW CLUB DR	Cross Street: PAW VILLAGE RD	Location: S
ADA ID: 3319FC1945E8	Ramp Type: PerpDiag	Initial Pass/Fail: Fail	Overall Compliance: No
Codes/Mitigation Info/Possible Solution		Field Measurements/Component Compliance	
Severity Score: 8.75

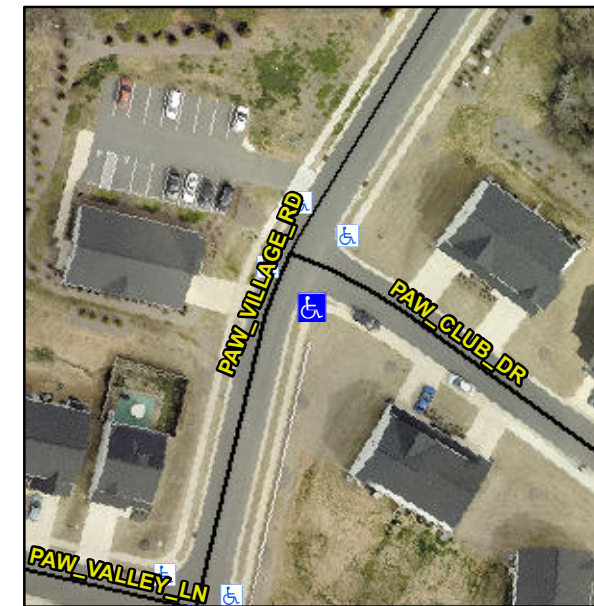
Compliance	Description	Data	Compliance	Description	Data
N/A	Ramp Length (in)	60.0	Yes	Ramp Slope (%)	6.3
No	Ramp Width (in)	47.5	Yes	Ramp XSlope (%)	0.9
N/A	Flare Type LT	N/A	N/A	Flare Type RT	N/A
N/A	Flare Slope LT (%)	N/A	N/A	Flare Slope RT (%)	N/A
N/A	Flare Traversable LT?	N/A	N/A	Flare Traversable RT?	N/A
N/A	Landing Length (in)	N/A	N/A	DWS Provided?	N/A
N/A	Landing Width (in)	N/A	N/A	DWS Contrast?	N/A
N/A	Landing Slope (%)	N/A	N/A	DWS Length (in)	N/A
N/A	Landing X Slope (%)	N/A	N/A	DWS Full Width?	N/A
N/A	Landing Curb? (Y/N)	N/A	N/A	DWS Offset (in)	N/A
N/A	Shared Landing?	N/A			
N/A	Gutter Ponding?	N/A	N/A	Gutter Slope (%)	N/A
N/A	Gutter Lip Ht (in)	N/A	N/A	Gutter X Slope (%)	N/A
N/A	Painted X Walk1?	No	N/A	Painted X Walk2?	No
	X Walk 1 Direction	To NE		X Walk 2 Direction	To NW
N/A	X Walk 1 Width (in)	N/A	N/A	X Walk 2 Width (in)	N/A
	X Walk 1 Slope (%)	4.5		X Walk 2 Slope (%)	5.6
	X Walk 1 X Slope (%)	4.3		X Walk 2 X Slope (%)	4.9

N/A	Ramp inside XWalk1?	N/A	N/A	Ramp inside XWalk2?	N/A
	Road Slope (%)	1.6	N/A	Clear Space?	N/A
	Road X Slope (%)	6.3	N/A	Clear Space to XWalk (in)	N/A
N/A	Any Obstructions?	N/A	N/A	Storm Grate/Utility Hazard?	N/A
	Obstruction Type			Storm Grate/Utility Type	
		N/A			N/A
			Yes	Surface Condition? (G/P)	Good

Possible Solutions:

Remove & Replace Curb Ramp With Two New Directional Ramps or Equivalent.

Total Cost: \$ 3200.00
