Access Compliance Report

Public Rights-of-Way

(Curb Ramps)

Intersection ID: 16251	Main Street: N_SHARON_AMITY_RD	Cross Street: BUENA_VISTA_AV	Location: NW
ADA ID: 331E8EADB7B5	Ramp Type: PerpDiag	Initial Pass/Fail: Fail	Overall Compliance: No
		Severity Score: 25

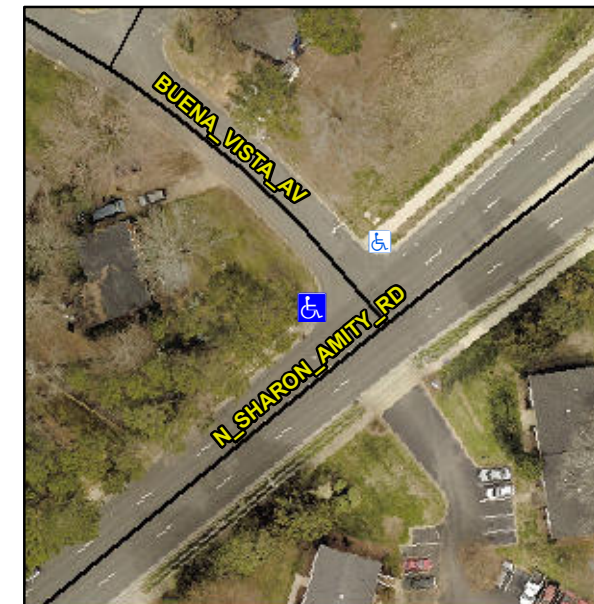
Not Found, R304.2.2, R304.5.3

Compliance	Description	Data	Compliance	Description	Data
N/A	Ramp Length (in)	94.0	No	Ramp Slope (%)	8.5
Yes	Ramp Width (in)	61.0	No	Ramp XSlope (%)	5.4
N/A	Flare Type LT	N/A	N/A	Flare Type RT	N/A
N/A	Flare Slope LT (%)	N/A	N/A	Flare Slope RT (%)	N/A
N/A	Flare Traversable LT?	N/A	N/A	Flare Traversable RT?	N/A
N/A	Landing Length (in)	N/A	N/A	DWS Provided?	N/A
N/A	Landing Width (in)	N/A	N/A	DWS Contrast?	N/A
N/A	Landing Slope (%)	N/A	N/A	DWS Length (in)	N/A
N/A	Landing X Slope (%)	N/A	N/A	DWS Full Width?	N/A
N/A	Landing Curb? (Y/N)	N/A	N/A	DWS Offset (in)	N/A
N/A	Shared Landing?	N/A			
N/A	Gutter Ponding?	N/A	N/A	Gutter Slope (%)	N/A
N/A	Gutter Lip Ht (in)	N/A	N/A	Gutter X Slope (%)	N/A
N/A	Painted X Walk1?	No	N/A	Painted X Walk2?	No
	X Walk 1 Direction	To SE		X Walk 2 Direction	To NE
N/A	X Walk 1 Width (in)	N/A	N/A	X Walk 2 Width (in)	N/A
	X Walk 1 Slope (%)	7.8		X Walk 2 Slope (%)	1.3
	X Walk 1 X Slope (%)	2.6		X Walk 2 X Slope (%)	9.0

N/A	Ramp inside XWalk1?	N/A	N/A	Ramp inside XWalk2?	N/A
	Road Slope (%)	5.0	N/A	Clear Space?	N/A
	Road X Slope (%)	10.2	N/A	Clear Space to XWalk (in)	N/A
N/A	Any Obstructions?	N/A	N/A	Storm Grate/Utility Hazard?	N/A
	Obstruction Type			Storm Grate/Utility Type	
		N/A			N/A
			Yes	Surface Condition? (G/P)	Good

Remove & Replace Curb Ramp With Two New Directional Ramps or Equivalent.
