Access Compliance Report

Public Rights-of-Way

(Curb Ramps)

Intersection ID: 13787	Main Street: CHARLOTTETOWNE_AV	Cross Street: E_4TH_ST	Location: NW
ADA ID: 3325E4AB59CD	Ramp Type: Perp	Initial Pass/Fail: Fail	Overall Compliance: No
Severity Score: 13.75			
Codes/Mitigation Info/Possible Solution		Field Measurements/Component Compliance

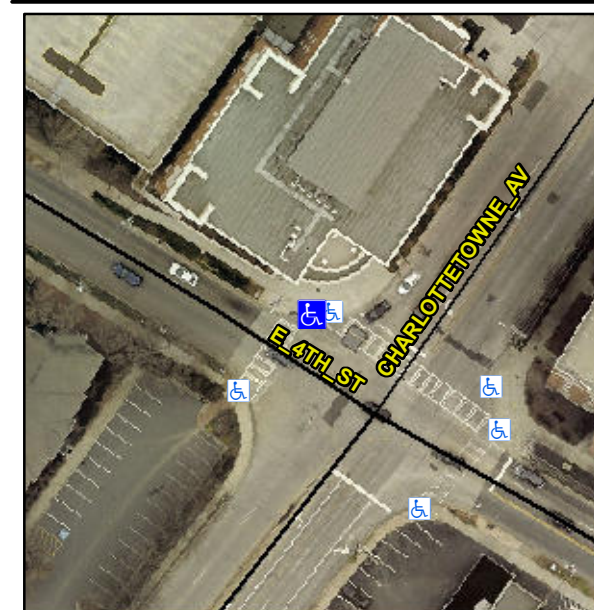
Not Found, R304.2.2

Compliance	Description	Data	Compliance	Description	Data
N/A	Ramp Length (in)	96.0	No	Ramp Slope (%)	10.4
Yes	Ramp Width (in)	59.0	Yes	Ramp XSlope (%)	4.5
N/A	Flare Type LT	N/A	N/A	Flare Type RT	N/A
N/A	Flare Slope LT (%)	N/A	N/A	Flare Slope RT (%)	N/A
N/A	Flare Traversable LT?	N/A	N/A	Flare Traversable RT?	N/A
N/A	Landing Length (in)	N/A	N/A	DWS Provided?	N/A
N/A	Landing Width (in)	N/A	N/A	DWS Contrast?	N/A
N/A	Landing Slope (%)	N/A	N/A	DWS Length (in)	N/A
N/A	Landing X Slope (%)	N/A	N/A	DWS Full Width?	N/A
N/A	Landing Curb? (Y/N)	N/A	N/A	DWS Offset (in)	N/A
N/A	Shared Landing?	N/A			
N/A	Gutter Ponding?	N/A	N/A	Gutter Slope (%)	N/A
N/A	Gutter Lip Ht (in)	N/A	N/A	Gutter X Slope (%)	N/A
N/A	Painted X Walk1?	Yes	N/A	Painted X Walk2?	N/A
	X Walk 1 Direction	To SW		X Walk 2 Direction	N/A
N/A	X Walk 1 Width (in)	120.0	N/A	X Walk 2 Width (in)	N/A
	X Walk 1 Slope (%)	6.1		X Walk 2 Slope (%)	N/A
	X Walk 1 X Slope (%)	5.0		X Walk 2 X Slope (%)	N/A

N/A	Ramp inside XWalk1?	Yes	N/A	Ramp inside XWalk2?	N/A
	Road Slope (%)	N/A	N/A	Clear Space?	N/A
	Road X Slope (%)	N/A	N/A	Clear Space to XWalk (in)	N/A
N/A	Any Obstructions?	N/A	N/A	Storm Grate/Utility Hazard?	N/A
	Obstruction Type			Storm Grate/Utility Type	
		N/A			N/A
		Yes		Surface Condition? (G/P)	Good

Possible Solutions:

Remove & Replace Entire Ramp.
