Access Compliance Report

Public Rights-of-Way

(Curb Ramps)

Intersection ID: N/A	Main Street: N_TRYON_ST	Cross Street: CANDLER_LN	Location: NW
ADA ID: 332B3EA2E777	Ramp Type: Directional1	Initial Pass/Fail: Fail	Overall Compliance: No
Severity Score: 13.75			
Codes/Mitigation Info/Possible Solution		Field Measurements/Component Compliance

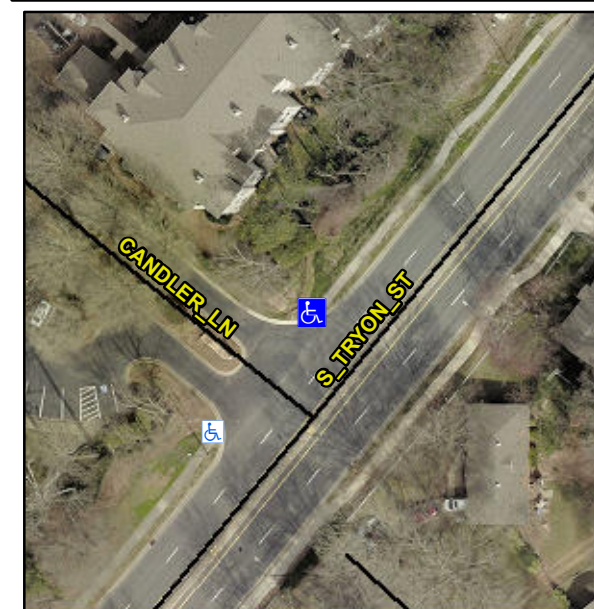
R304.2.2, R304.5.3

Compliance	Description	Data	Compliance	Description	Data
N/A	Ramp Length (in)	32.0	N/A	Grade Break?	N/A
Yes	Ramp Width (in)	60.0	N/A	Grade Break Slope (%)	0.0
No	Ramp Slope (%)	8.7	N/A	Grade Break XSlope (%)	0.0
No	Ramp XSlope (%)	4.2			
N/A	Flare Type LT	N/A	N/A	Flare Type RT	N/A
N/A	Flare Slope LT (%)	N/A	N/A	Flare Slope RT (%)	0.0
N/A	Flare Traversable LT?	N/A	N/A	Flare Traversable RT?	N/A
N/A	Landing Length (in)	0.0	N/A	DWS Provided?	N/A
N/A	Landing Width (in)	0.0	N/A	DWS Contrast?	N/A
N/A	Landing Slope (%)	0.0	N/A	DWS Length (in)	N/A
N/A	Landing X Slope (%)	0.0	N/A	DWS Full Width?	N/A
N/A	Landing Curb? (Y/N)	N/A	N/A	DWS Offset LT (in)	N/A
N/A	Shared Landing?	N/A	N/A	DWS Offset RT (in)	N/A
N/A	Gutter Ponding?	0.0	N/A	Gutter Slope (%)	N/A
N/A	Gutter Lip Ht (in)	0.0	N/A	Gutter X Slope (%)	N/A
N/A	Painted X Walk1?	No		Road Slope (%)	1.2
	X Walk 1 Direction	To SW		Road X Slope (%)	0.2
	X Walk 1 Width (in)	N/A		Clear Space?	N/A

X Walk 1 Slope (%)	1.2	N/A	Clear Space to XWalk (in)	N/A
	X Walk 1 X Slope (%)	0.2	N/A	Storm Grate/Utility Hazard?	N/A
N/A	Ramp inside XWalk1?	N/A		Storm Grate/Utility Type	
N/A	Any Obstructions?	N/A			N/A
	Obstruction Type		Yes	Surface Condition? (G/P)	Good
			N/A	Curb Slope (%)	6.2

Possible Solutions:

Remove & Replace Entire Ramp.
