# Access Compliance Report

## Public Rights-of-Way

### (Curb Ramps)

Intersection ID: 15212	Main Street: GRIFFITH_ST	Cross Street: YOUNGBLOOD_ST	Location:	N
ADA ID: 333F8835CCDB	Ramp Type: PerpDiag	Initial Pass/Fail: Fail	Overall Compliance: No	Severity Score: 33.75
Codes/Mitigation Info/Possible Solution		Field Measurements/Component Compliance

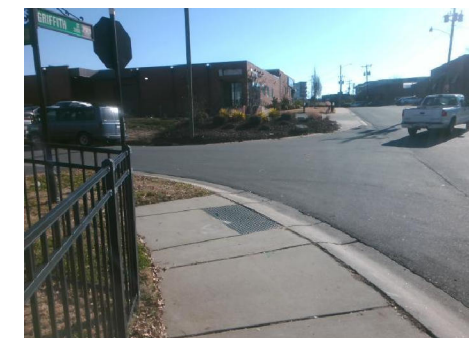
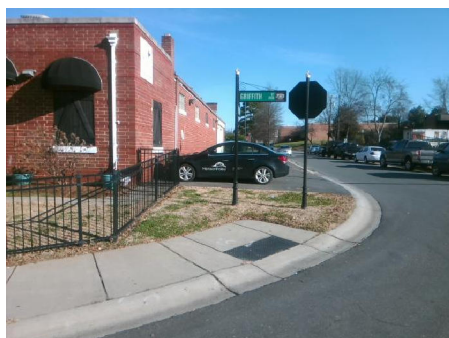
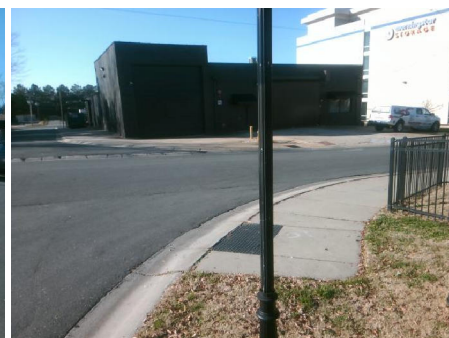
**Not Found, R304.5.1, R304.5.3**

Compliance	Description	Data	Compliance	Description	Data
N/A	Ramp Length (in)	70.0	Yes	Ramp Slope (%)	5.1
No	Ramp Width (in)	46.5	No	Ramp XSlope (%)	7.0
N/A	Flare Type LT	N/A	N/A	Flare Type RT	N/A
N/A	Flare Slope LT (%)	N/A	N/A	Flare Slope RT (%)	N/A
N/A	Flare Traversable LT?	N/A	N/A	Flare Traversable RT?	N/A
N/A	Landing Length (in)	N/A	N/A	DWS Provided?	N/A
N/A	Landing Width (in)	N/A	N/A	DWS Contrast?	N/A
N/A	Landing Slope (%)	N/A	N/A	DWS Length (in)	N/A
N/A	Landing X Slope (%)	N/A	N/A	DWS Full Width?	N/A
N/A	Landing Curb? (Y/N)	N/A	N/A	DWS Offset (in)	N/A
N/A	Shared Landing?	N/A			
N/A	Gutter Ponding?	N/A	N/A	Gutter Slope (%)	N/A
N/A	Gutter Lip Ht (in)	N/A	N/A	Gutter X Slope (%)	N/A
N/A	Painted X Walk1?	No	N/A	Painted X Walk2?	No
	X Walk 1 Direction	To SW		X Walk 2 Direction	To SE
N/A	X Walk 1 Width (in)	N/A	N/A	X Walk 2 Width (in)	N/A
	X Walk 1 Slope (%)	1.8		X Walk 2 Slope (%)	5.6
	X Walk 1 X Slope (%)	6.2		X Walk 2 X Slope (%)	0.8

N/A	Ramp inside XWalk1?	N/A	N/A	Ramp inside XWalk2?	N/A
	Road Slope (%)	5.6	N/A	Clear Space?	N/A
	Road X Slope (%)	4.9	N/A	Clear Space to XWalk (in)	N/A
N/A	Any Obstructions?	N/A	N/A	Storm Grate/Utility Hazard?	N/A
	Obstruction Type			Storm Grate/Utility Type	
		N/A			N/A
			Yes	Surface Condition? (G/P)	Good

**Remove & Replace Curb Ramp With Two New Directional Ramps or Equivalent.**

Total Cost: \$ 3200.00
