Access Compliance Report

Public Rights-of-Way

(Curb Ramps)

Intersection ID: 10039218	Main Street: SUNNINGHILL_PARK_RD	Cross Street: N/A	Location: SE
ADA ID: 3344313E8E30	Ramp Type: PerpDiag	Initial Pass/Fail: Fail	Overall Compliance: No
Codes/Mitigation Info/Possible Solution		Field Measurements/Component Compliance	
Severity Score: 35

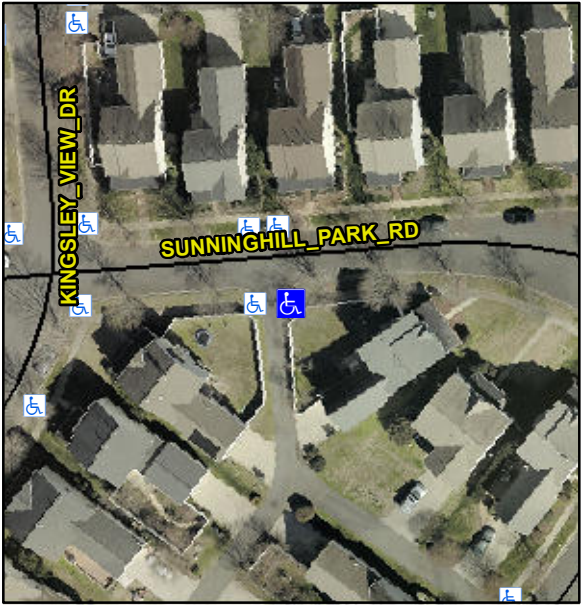
Possible Solutions:	Compliance	Description	Data	Compliance	Description	Data
	Remove & Replace Curb Ramp With Two New Directional Ramps or Equivalent.	N/A	Ramp Length (in)	67.0	No	Ramp Slope (%)	13.3
		No	Ramp Width (in)	38.0	Yes	Ramp XSlope (%)	2.6
		N/A	Flare Type LT	N/A	N/A	Flare Type RT	N/A
		N/A	Flare Slope LT (%)	N/A	N/A	Flare Slope RT (%)	N/A
		N/A	Flare Traversable LT?	N/A	N/A	Flare Traversable RT?	N/A
		N/A	Landing Length (in)	N/A	N/A	DWS Provided?	N/A
		N/A	Landing Width (in)	N/A	N/A	DWS Contrast?	N/A
		N/A	Landing Slope (%)	N/A	N/A	DWS Length (in)	N/A
		N/A	Landing X Slope (%)	N/A	N/A	DWS Full Width?	N/A
<p>Surveyor Notes:</p> <p>N/A</p> <p>PROW/ADA:</p> <p>Not Found, R304.5.1, R304.2.2</p>		N/A	Landing Curb? (Y/N)	N/A	N/A	DWS Offset (in)	N/A
		N/A	Shared Landing?	N/A			
		N/A	Gutter Ponding?	N/A	N/A	Gutter Slope (%)	N/A
		N/A	Gutter Lip Ht (in)	N/A	N/A	Gutter X Slope (%)	N/A
		N/A	Painted X Walk1?	No	N/A	Painted X Walk2?	No

X Walk 1 Direction	To N		X Walk 2 Direction	To W
		N/A	X Walk 1 Width (in)	N/A	N/A	X Walk 2 Width (in)	N/A
			X Walk 1 Slope (%)	3.4		X Walk 2 Slope (%)	0.1
			X Walk 1 X Slope (%)	0.6		X Walk 2 X Slope (%)	4.5
		N/A	Ramp inside XWalk1?	N/A	N/A	Ramp inside XWalk2?	N/A
<p>Street 1 Name</p> <p>Stop Condition-Street 2</p> <p>Street 2 Name</p> <p>Stop Condition-Street 1</p>			Road Slope (%)	2.9	N/A	Clear Space?	N/A
			Road X Slope (%)	0.6	N/A	Clear Space to XWalk (in)	N/A
		N/A	Any Obstructions?	N/A	N/A	Storm Grate/Utility Hazard?	N/A
			Obstruction Type			Storm Grate/Utility Type	
					N/A		N/A
					Yes	Surface Condition? (G/P)	Good
Total Cost:		\$	3200.00
