# Access Compliance Report

## Public Rights-of-Way

### (Curb Ramps)

| Intersection ID: 15300 | Main Street: GREENHAVEN_LN | Cross Street: PIERSON_DR | Location: SW |

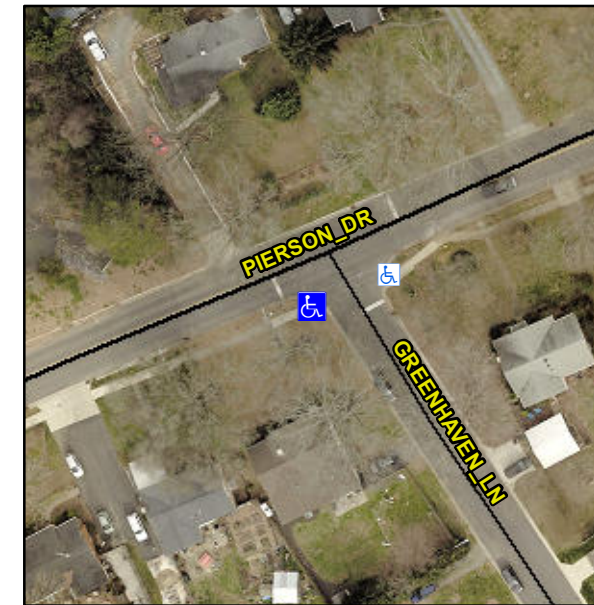
| ADA ID: 3344E3140C6C | Ramp Type: Directional1 | Initial Pass/Fail: Pass | Overall Compliance: No |

**R304.2.2-Perp, R304.3.2-Para**

| Compliance | Description | Data | Compliance | Description | Data |
|---|---|---|---|---|---|
| No | Landing Slope (%) | 5.9 | Yes | DWS Length (in) | 24.0 |

**Remove & Replace Landing.**

Total Cost: \$ 500.00
