# Access Compliance Report

## Public Rights-of-Way

### (Curb Ramps)

Intersection ID: 8668	Main Street: BROWNSTONE_ST	Cross Street: HATERAS_AV	Location: SE
ADA ID: 334ED5C49A69	Ramp Type: Perp	Initial Pass/Fail: Fail	Overall Compliance: No
Severity Score: 33.75			
Codes/Mitigation Info/Possible Solution		Field Measurements/Component Compliance

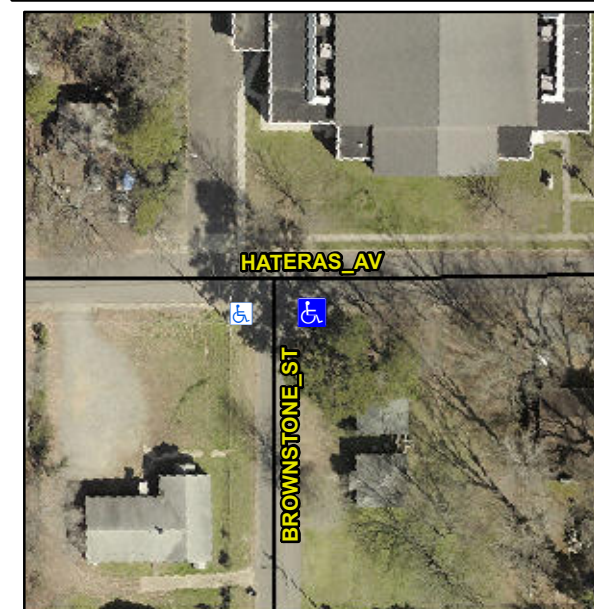
**Not Found, R304.5.1, R304.2.2, R304.5.3**

Compliance	Description	Data	Compliance	Description	Data
N/A	Ramp Length (in)	46.0	No	Ramp Slope (%)	10.3
No	Ramp Width (in)	45.0	No	Ramp XSlope (%)	6.9
N/A	Flare Type LT	N/A	N/A	Flare Type RT	N/A
N/A	Flare Slope LT (%)	N/A	N/A	Flare Slope RT (%)	N/A
N/A	Flare Traversable LT?	N/A	N/A	Flare Traversable RT?	N/A
N/A	Landing Length (in)	N/A	N/A	DWS Provided?	N/A
N/A	Landing Width (in)	N/A	N/A	DWS Contrast?	N/A
N/A	Landing Slope (%)	N/A	N/A	DWS Length (in)	N/A
N/A	Landing X Slope (%)	N/A	N/A	DWS Full Width?	N/A
N/A	Landing Curb? (Y/N)	N/A	N/A	DWS Offset (in)	N/A
N/A	Shared Landing?	N/A			
N/A	Gutter Ponding?	N/A	N/A	Gutter Slope (%)	N/A
N/A	Gutter Lip Ht (in)	N/A	N/A	Gutter X Slope (%)	N/A
N/A	Painted X Walk1?	No	N/A	Painted X Walk2?	N/A
	X Walk 1 Direction	To W		X Walk 2 Direction	N/A
N/A	X Walk 1 Width (in)	N/A	N/A	X Walk 2 Width (in)	N/A
	X Walk 1 Slope (%)	5.2		X Walk 2 Slope (%)	N/A
	X Walk 1 X Slope (%)	2.5		X Walk 2 X Slope (%)	N/A

**Remove & Replace Entire Ramp.**

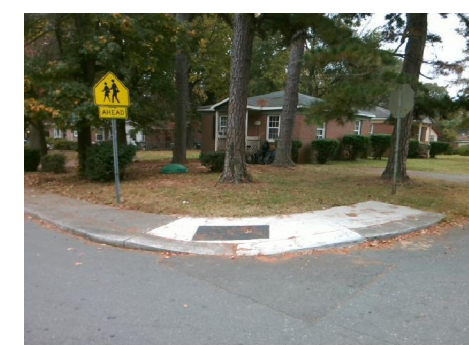
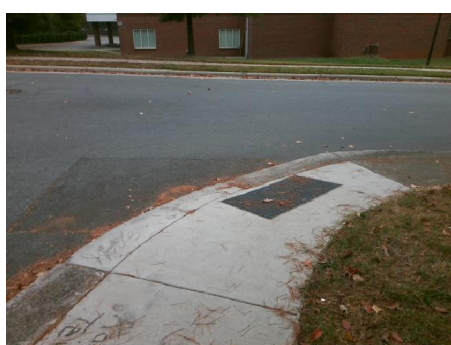
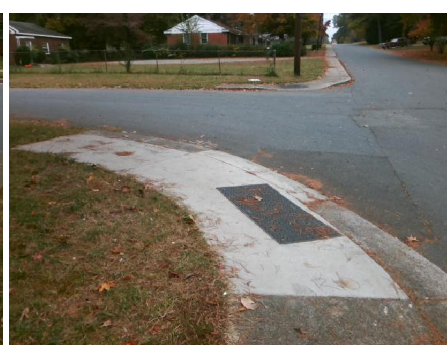
N/A	Ramp inside XWalk1?	N/A	N/A	Ramp inside XWalk2?	N/A
	Road Slope (%)	N/A	N/A	Clear Space?	N/A
	Road X Slope (%)	N/A	N/A	Clear Space to XWalk (in)	N/A
N/A	Any Obstructions?	N/A	N/A	Storm Grate/Utility Hazard?	N/A
	Obstruction Type			Storm Grate/Utility Type	
		N/A			N/A
			Yes	Surface Condition? (G/P)	Good
