Access Compliance Report

Public Rights-of-Way

(Curb Ramps)

Intersection ID: 3449	Main Street: ENCHANTMENT_COVE_LN	Cross Street: OVERLOOK_MOUNTAIN_DR	Location: NW
ADA ID: 3352437668C8	Ramp Type: Perp	Initial Pass/Fail: Pass	Overall Compliance: No
Severity Score: 0.25			
Codes/Mitigation Info/Possible Solution		Field Measurements/Component Compliance

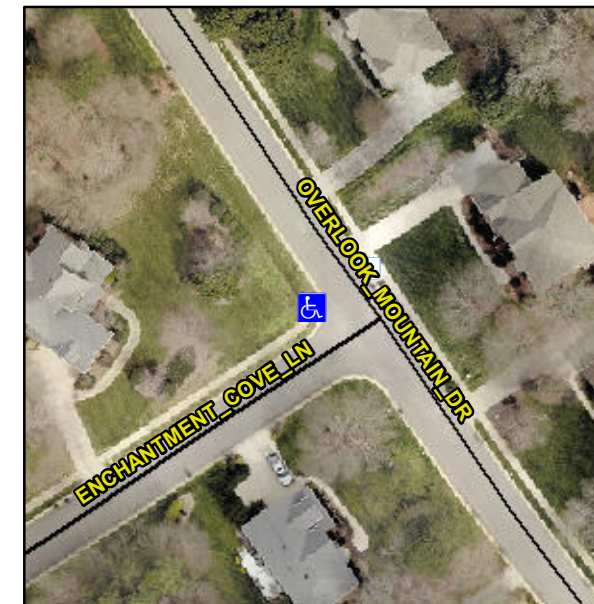
Compliance	Description	Data	Compliance	Description	Data
N/A	Ramp Length (in)	60.0	Yes	Ramp Slope (%)	8.0
Yes	Ramp Width (in)	48.0	No	Ramp XSlope (%)	3.0
N/A	Flare Type LT	Sloped	N/A	Flare Type RT	N/A
N/A	Flare Slope LT (%)	4.4	N/A	Flare Slope RT (%)	5.1
N/A	Flare Traversable LT?	Yes	N/A	Flare Traversable RT?	No
No	Landing Length (in)	38.0	Yes	DWS Provided?	Yes
Yes	Landing Width (in)	48.0	Yes	DWS Contrast?	Yes
No	Landing Slope (%)	3.1	Yes	DWS Length (in)	24.0
No	Landing X Slope (%)	3.8	Yes	DWS Full Width?	Yes
N/A	Landing Curb? (Y/N)	No	No	DWS Offset (in)	4.5
N/A	Shared Landing?	No			
Yes	Gutter Ponding?	No	Yes	Gutter Slope (%)	3.2
Yes	Gutter Lip Ht (in)	0.0	Yes	Gutter X Slope (%)	1.2
N/A	Painted X Walk1?	No	N/A	Painted X Walk2?	N/A
	X Walk 1 Direction	To NE		X Walk 2 Direction	N/A
N/A	X Walk 1 Width (in)	N/A	N/A	X Walk 2 Width (in)	N/A
	X Walk 1 Slope (%)	1.1		X Walk 2 Slope (%)	N/A
	X Walk 1 X Slope (%)	2.8		X Walk 2 X Slope (%)	N/A

N/A	Ramp inside XWalk1?	N/A	N/A	Ramp inside XWalk2?	N/A
	Road Slope (%)	N/A	N/A	Clear Space?	Yes
	Road X Slope (%)	N/A	N/A	Clear Space to XWalk (in)	N/A
Yes	Any Obstructions?	No	Yes	Storm Grate/Utility Hazard?	No
	Obstruction Type			Storm Grate/Utility Type	
		N/A			N/A
			Yes	Surface Condition? (G/P)	Good

Possible Solutions:

Remove & Replace Entire Ramp.

**R304.5.3, R304.2.1, R304.2.2-Perp,
R304.3.2-Para, R305.2**
