Access Compliance Report

Public Rights-of-Way

(Curb Ramps)

Intersection ID: 20236	Main Street: CAMERON_VALLEY_PY	Cross Street: MORRISON_BV	Location: NE
ADA ID: 335E225A5419	Ramp Type: Directional1	Initial Pass/Fail: Fail	Overall Compliance: No
Severity Score: 1.25			
Codes/Mitigation Info/Possible Solution		Field Measurements/Component Compliance

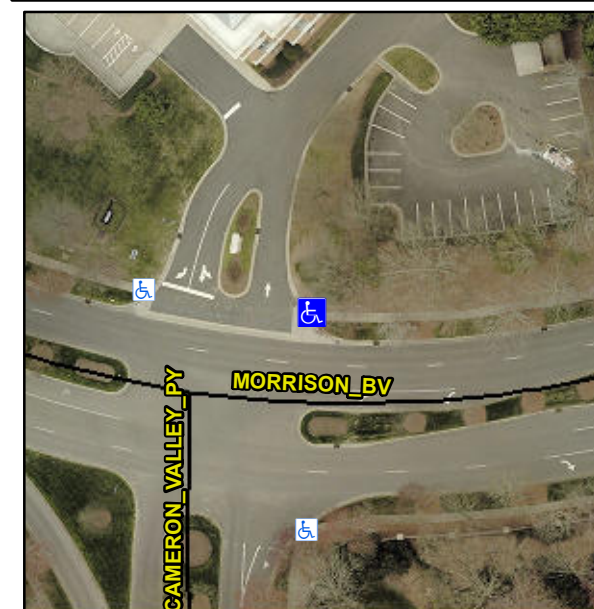
Compliance	Description	Data	Compliance	Description	Data
N/A	Ramp Length (in)	59.5	N/A	Grade Break?	N/A
Yes	Ramp Width (in)	59.0	N/A	Grade Break Slope (%)	0.0
Yes	Ramp Slope (%)	8.2	N/A	Grade Break XSlope (%)	0.0
No	Ramp XSlope (%)	3.7			
N/A	Flare Type LT	N/A	N/A	Flare Type RT	N/A
N/A	Flare Slope LT (%)	N/A	N/A	Flare Slope RT (%)	0.0
N/A	Flare Traversable LT?	N/A	N/A	Flare Traversable RT?	N/A
N/A	Landing Length (in)	0.0	N/A	DWS Provided?	N/A
N/A	Landing Width (in)	0.0	N/A	DWS Contrast?	N/A
N/A	Landing Slope (%)	0.0	N/A	DWS Length (in)	N/A
N/A	Landing X Slope (%)	0.0	N/A	DWS Full Width?	N/A
N/A	Landing Curb? (Y/N)	N/A	N/A	DWS Offset LT (in)	N/A
N/A	Shared Landing?	N/A	N/A	DWS Offset RT (in)	N/A
N/A	Gutter Ponding?	0.0	N/A	Gutter Slope (%)	N/A
N/A	Gutter Lip Ht (in)	0.0	N/A	Gutter X Slope (%)	N/A
N/A	Painted X Walk1?	No		Road Slope (%)	0.8
	X Walk 1 Direction	To W		Road X Slope (%)	1.1
	X Walk 1 Width (in)	N/A		Clear Space?	N/A

X Walk 1 Slope (%)	0.8	N/A	Clear Space to XWalk (in)	N/A
	X Walk 1 X Slope (%)	1.1	N/A	Storm Grate/Utility Hazard?	N/A
N/A	Ramp inside XWalk1?	N/A		Storm Grate/Utility Type	
N/A	Any Obstructions?	N/A			N/A
	Obstruction Type		Yes	Surface Condition? (G/P)	Good
			N/A	Curb Slope (%)	18.4

Possible Solutions:

Remove & Replace Entire Ramp.

R304.5.3
