Access Compliance Report

Public Rights-of-Way

(Curb Ramps)

Intersection ID: 23690	Main Street: CRESSIDA_DR	Cross Street: E WESTINGHOUSE BV	Location: NE
ADA ID: 33626D1CB888	Ramp Type: PerpDiag	Initial Pass/Fail: Fail	Overall Compliance: No
Severity Score: 13.75			
Codes/Mitigation Info/Possible Solution		Field Measurements/Component Compliance

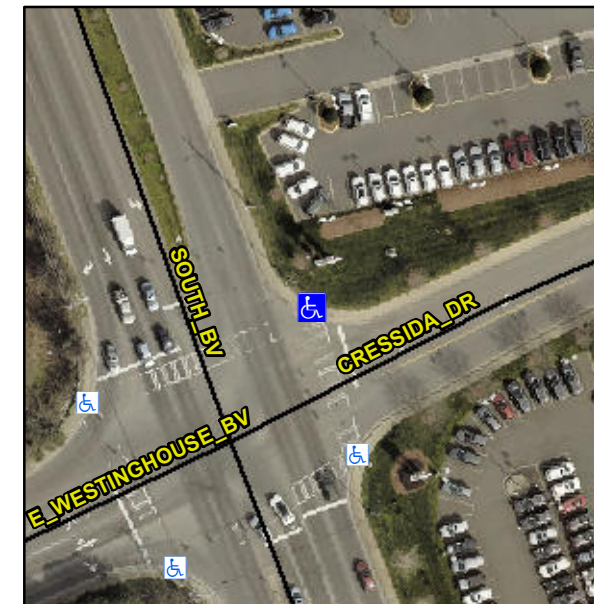
Not Found, R304.2.2, R304.5.3

Compliance	Description	Data	Compliance	Description	Data
N/A	Ramp Length (in)	58.0	No	Ramp Slope (%)	11.8
Yes	Ramp Width (in)	48.0	No	Ramp XSlope (%)	2.4
N/A	Flare Type LT	N/A	N/A	Flare Type RT	N/A
N/A	Flare Slope LT (%)	N/A	N/A	Flare Slope RT (%)	N/A
N/A	Flare Traversable LT?	N/A	N/A	Flare Traversable RT?	N/A
N/A	Landing Length (in)	N/A	N/A	DWS Provided?	N/A
N/A	Landing Width (in)	N/A	N/A	DWS Contrast?	N/A
N/A	Landing Slope (%)	N/A	N/A	DWS Length (in)	N/A
N/A	Landing X Slope (%)	N/A	N/A	DWS Full Width?	N/A
N/A	Landing Curb? (Y/N)	N/A	N/A	DWS Offset (in)	N/A
N/A	Shared Landing?	N/A			
N/A	Gutter Ponding?	N/A	N/A	Gutter Slope (%)	N/A
N/A	Gutter Lip Ht (in)	N/A	N/A	Gutter X Slope (%)	N/A
N/A	Painted X Walk1?	Yes	N/A	Painted X Walk2?	Yes
	X Walk 1 Direction	To W		X Walk 2 Direction	To S
N/A	X Walk 1 Width (in)	114.0	N/A	X Walk 2 Width (in)	114.0
	X Walk 1 Slope (%)	0.1		X Walk 2 Slope (%)	0.5
	X Walk 1 X Slope (%)	0.9		X Walk 2 X Slope (%)	0.3

N/A	Ramp inside XWalk1?	Yes	N/A	Ramp inside XWalk2?	Yes
	Road Slope (%)	1.2	N/A	Clear Space?	N/A
	Road X Slope (%)	0.4	N/A	Clear Space to XWalk (in)	N/A
N/A	Any Obstructions?	N/A	N/A	Storm Grate/Utility Hazard?	N/A
	Obstruction Type			Storm Grate/Utility Type	
		N/A			N/A
		Yes		Surface Condition? (G/P)	Good

Remove & Replace Curb Ramp With Two New Directional Ramps or Equivalent.
