Access Compliance Report

Public Rights-of-Way

(Curb Ramps)

Intersection ID: 53416	Main Street: WAVERLY_CENTER_DR	Cross Street: SOUTHGROVE_ST	Location: SE
ADA ID: 33629F133103	Ramp Type: Perp	Initial Pass/Fail: Fail	Overall Compliance: No
Severity Score: 8.75			
Codes/Mitigation Info/Possible Solution		Field Measurements/Component Compliance

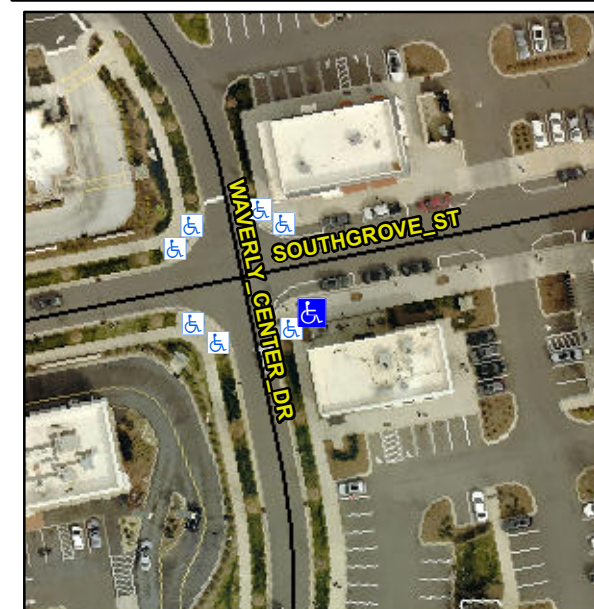
Not Found, R304.5.1

Compliance	Description	Data	Compliance	Description	Data
N/A	Ramp Length (in)	58.0	Yes	Ramp Slope (%)	5.3
No	Ramp Width (in)	45.0	Yes	Ramp XSlope (%)	0.7
N/A	Flare Type LT	N/A	N/A	Flare Type RT	N/A
N/A	Flare Slope LT (%)	N/A	N/A	Flare Slope RT (%)	N/A
N/A	Flare Traversable LT?	N/A	N/A	Flare Traversable RT?	N/A
N/A	Landing Length (in)	N/A	N/A	DWS Provided?	N/A
N/A	Landing Width (in)	N/A	N/A	DWS Contrast?	N/A
N/A	Landing Slope (%)	N/A	N/A	DWS Length (in)	N/A
N/A	Landing X Slope (%)	N/A	N/A	DWS Full Width?	N/A
N/A	Landing Curb? (Y/N)	N/A	N/A	DWS Offset (in)	N/A
N/A	Shared Landing?	N/A			
N/A	Gutter Ponding?	N/A	N/A	Gutter Slope (%)	N/A
N/A	Gutter Lip Ht (in)	N/A	N/A	Gutter X Slope (%)	N/A
N/A	Painted X Walk1?	No	N/A	Painted X Walk2?	N/A
	X Walk 1 Direction	To N		X Walk 2 Direction	N/A
N/A	X Walk 1 Width (in)	N/A	N/A	X Walk 2 Width (in)	N/A
	X Walk 1 Slope (%)	2.9		X Walk 2 Slope (%)	N/A
	X Walk 1 X Slope (%)	1.8		X Walk 2 X Slope (%)	N/A

N/A	Ramp inside XWalk1?	N/A	N/A	Ramp inside XWalk2?	N/A
	Road Slope (%)	N/A	N/A	Clear Space?	N/A
	Road X Slope (%)	N/A	N/A	Clear Space to XWalk (in)	N/A
N/A	Any Obstructions?	N/A	N/A	Storm Grate/Utility Hazard?	N/A
	Obstruction Type			Storm Grate/Utility Type	
		N/A			N/A
			Yes	Surface Condition? (G/P)	Good

Remove & Replace Entire Ramp.
