# Access Compliance Report

## Public Rights-of-Way

### (Curb Ramps)

Intersection ID: 14435	Main Street: WEST_BV	Cross Street: DAWNALIA_DR	Location: SE
ADA ID: 3364FB9FD6EC	Ramp Type: Directional1	Initial Pass/Fail: Fail	Overall Compliance: No
Severity Score: 1.25			
Codes/Mitigation Info/Possible Solution		Field Measurements/Component Compliance

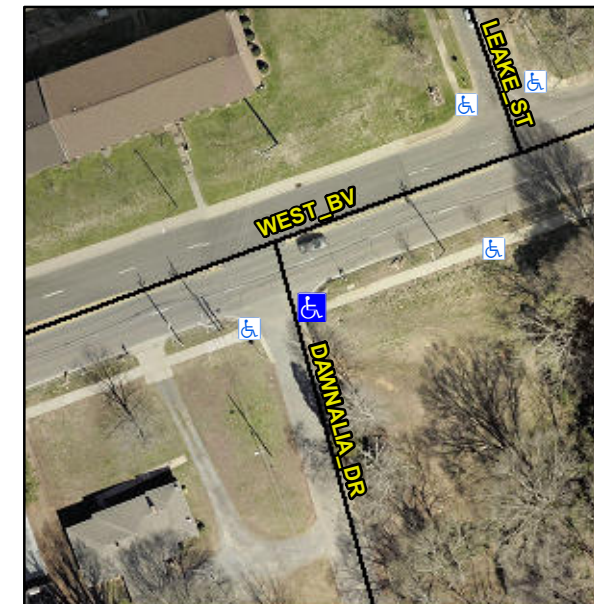
Compliance	Description	Data	Compliance	Description	Data
N/A	Ramp Length (in)	109.0	N/A	Grade Break?	N/A
Yes	Ramp Width (in)	71.0	N/A	Grade Break Slope (%)	0.0
Yes	Ramp Slope (%)	5.0	N/A	Grade Break XSlope (%)	0.0
No	Ramp XSlope (%)	2.7			
N/A	Flare Type LT	N/A	N/A	Flare Type RT	N/A
N/A	Flare Slope LT (%)	N/A	N/A	Flare Slope RT (%)	0.0
N/A	Flare Traversable LT?	N/A	N/A	Flare Traversable RT?	N/A
N/A	Landing Length (in)	0.0	N/A	DWS Provided?	N/A
N/A	Landing Width (in)	0.0	N/A	DWS Contrast?	N/A
N/A	Landing Slope (%)	0.0	N/A	DWS Length (in)	N/A
N/A	Landing X Slope (%)	0.0	N/A	DWS Full Width?	N/A
N/A	Landing Curb? (Y/N)	N/A	N/A	DWS Offset LT (in)	N/A
N/A	Shared Landing?	N/A	N/A	DWS Offset RT (in)	N/A
N/A	Gutter Ponding?	0.0	N/A	Gutter Slope (%)	N/A
N/A	Gutter Lip Ht (in)	0.0	N/A	Gutter X Slope (%)	N/A
N/A	Painted X Walk1?	No		Road Slope (%)	3.0
	X Walk 1 Direction	To SW		Road X Slope (%)	1.1
	X Walk 1 Width (in)	N/A		Clear Space?	N/A

X Walk 1 Slope (%)	3.0	N/A	Clear Space to XWalk (in)	N/A
	X Walk 1 X Slope (%)	1.1	N/A	Storm Grate/Utility Hazard?	N/A
N/A	Ramp inside XWalk1?	N/A		Storm Grate/Utility Type	
N/A	Any Obstructions?	N/A			N/A
	Obstruction Type		Yes	Surface Condition? (G/P)	Good
			N/A	Curb Slope (%)	6.0

Possible Solutions:

**Remove & Replace Entire Ramp.**

**R304.5.3**

\$ 1600.00
