Access Compliance Report

Public Rights-of-Way

(Curb Ramps)

Intersection ID: 15263	Main Street: FOSTER_AV	Cross Street: S_TRYON_ST	Location: SW
ADA ID: 336FE7BC6273	Ramp Type: PerpDiag	Initial Pass/Fail: Fail	Overall Compliance: No
			Severity Score: 33.75

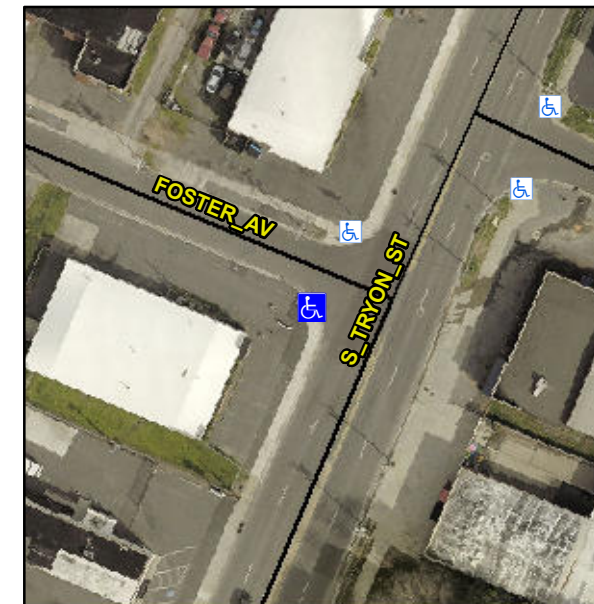
Not Found, R304.5.1, R304.5.3

Compliance	Description	Data	Compliance	Description	Data
N/A	Ramp Length (in)	67.0	Yes	Ramp Slope (%)	5.4
No	Ramp Width (in)	47.5	No	Ramp XSlope (%)	7.3
N/A	Flare Type LT	N/A	N/A	Flare Type RT	N/A
N/A	Flare Slope LT (%)	N/A	N/A	Flare Slope RT (%)	N/A
N/A	Flare Traversable LT?	N/A	N/A	Flare Traversable RT?	N/A
N/A	Landing Length (in)	N/A	N/A	DWS Provided?	N/A
N/A	Landing Width (in)	N/A	N/A	DWS Contrast?	N/A
N/A	Landing Slope (%)	N/A	N/A	DWS Length (in)	N/A
N/A	Landing X Slope (%)	N/A	N/A	DWS Full Width?	N/A
N/A	Landing Curb? (Y/N)	N/A	N/A	DWS Offset (in)	N/A
N/A	Shared Landing?	N/A			
N/A	Gutter Ponding?	N/A	N/A	Gutter Slope (%)	N/A
N/A	Gutter Lip Ht (in)	N/A	N/A	Gutter X Slope (%)	N/A
N/A	Painted X Walk1?	No	N/A	Painted X Walk2?	No
	X Walk 1 Direction	To E		X Walk 2 Direction	To NE
N/A	X Walk 1 Width (in)	N/A	N/A	X Walk 2 Width (in)	N/A
	X Walk 1 Slope (%)	2.4		X Walk 2 Slope (%)	2.1
	X Walk 1 X Slope (%)	2.2		X Walk 2 X Slope (%)	2.9

N/A	Ramp inside XWalk1?	N/A	N/A	Ramp inside XWalk2?	N/A
	Road Slope (%)	4.1	N/A	Clear Space?	N/A
	Road X Slope (%)	0.0	N/A	Clear Space to XWalk (in)	N/A
N/A	Any Obstructions?	N/A	N/A	Storm Grate/Utility Hazard?	N/A
	Obstruction Type			Storm Grate/Utility Type	
		N/A			N/A
			Yes	Surface Condition? (G/P)	Good

Remove & Replace Curb Ramp With Two New Directional Ramps or Equivalent.
