Access Compliance Report

Public Rights-of-Way

(Curb Ramps)

Intersection ID: 10028782	Main Street: HUNTINGTOWNE_FARMS_LN	Cross Street: N/A	Location: S
ADA ID: 3371A72391D7	Ramp Type: BlendTrans1	Initial Pass/Fail: Fail	Overall Compliance: No
		Severity Score: 12.5	
Codes/Mitigation Info/Possible Solution		Field Measurements/Component Compliance

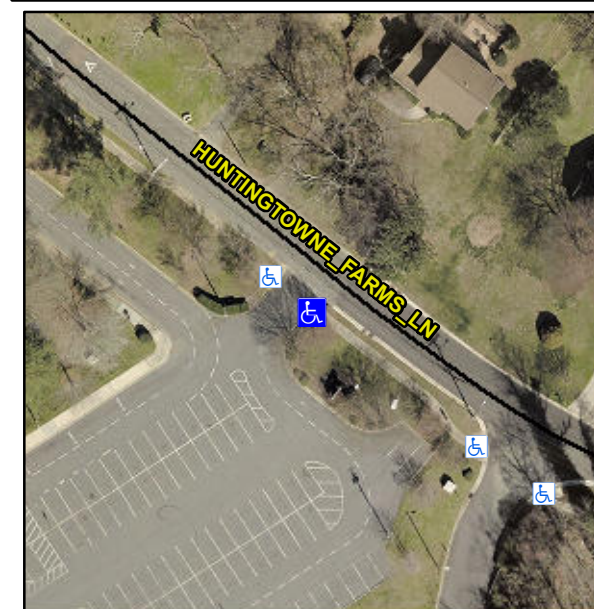
Compliance	Description	Data	Compliance	Description	Data
N/A	Ramp Length (in)	84.0	Yes	BlendTrans Slope (%)	0.2
Yes	Ramp Width (in)	48.0	No	BlendTrans XSlope (%)	6.7
N/A	Flare Type LT	N/A	N/A	Flare Type RT	N/A
N/A	Flare Slope LT (%)	N/A	N/A	Flare Slope RT (%)	N/A
N/A	Flare Traversable LT?	N/A	N/A	Flare Traversable RT?	N/A
N/A	Landing Length (in)	N/A	N/A	DWS Provided?	N/A
N/A	Landing Width (in)	N/A	N/A	DWS Contrast?	N/A
N/A	Landing Slope (%)	N/A	N/A	DWS Length (in)	N/A
N/A	Landing X Slope (%)	N/A	N/A	DWS Full Width?	N/A
N/A	Landing Curb? (Y/N)	N/A	N/A	DWS Offset (in)	N/A
N/A	Shared Landing?	N/A			
N/A	Gutter Ponding?	N/A	N/A	Gutter Slope (%)	N/A
N/A	Gutter Lip Ht (in)	N/A	N/A	Gutter X Slope (%)	N/A
N/A	Painted X Walk1?	No	N/A	Painted X Walk2?	N/A
	X Walk 1 Direction	To NW		X Walk 2 Direction	N/A
	X Walk 1 Width (in)	N/A		X Walk 2 Width (in)	N/A
	X Walk 1 Slope (%)	3.2		X Walk 2 Slope (%)	N/A
	X Walk 1 X Slope (%)	7.5		X Walk 2 X Slope (%)	N/A

N/A	Ramp inside XWalk1?	N/A	N/A	Ramp inside XWalk2?	N/A
	Road Slope (%)	7.5		Clear Space?	N/A
	Road X Slope (%)	3.2	N/A	Clear Space to XWalk (in)	N/A
N/A	Any Obstructions?	N/A	N/A	Storm Grate/Utility Hazard?	N/A
	Obstruction Type			Storm Grate/Utility Type	
		N/A			N/A
			Yes	Surface Condition? (G/P)	Good
			N/A	Curb Slope (%)	3.6

Possible Solutions:

Remove & Replace Curb Ramp With Two New Directional Ramps or Equivalent.

R304.5.3
