Access Compliance Report

Public Rights-of-Way

(Curb Ramps)

Intersection ID: 4850	Main Street: HARRINGTON_WOODS_RD	Cross Street: W_W_T_HARRIS_BV	Location: SW
ADA ID: 337755CD043A	Ramp Type: Perp	Initial Pass/Fail: Fail	Overall Compliance: No
Severity Score: 12.5			
Codes/Mitigation Info/Possible Solution		Field Measurements/Component Compliance

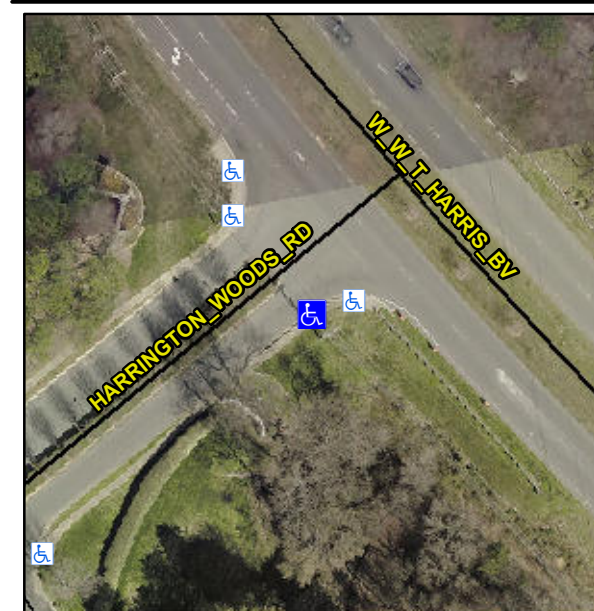
Not Found, R304.2.2

Compliance	Description	Data	Compliance	Description	Data
N/A	Ramp Length (in)	48.0	No	Ramp Slope (%)	8.7
Yes	Ramp Width (in)	48.0	Yes	Ramp XSlope (%)	1.6
N/A	Flare Type LT	N/A	N/A	Flare Type RT	N/A
N/A	Flare Slope LT (%)	N/A	N/A	Flare Slope RT (%)	N/A
N/A	Flare Traversable LT?	N/A	N/A	Flare Traversable RT?	N/A
N/A	Landing Length (in)	N/A	N/A	DWS Provided?	N/A
N/A	Landing Width (in)	N/A	N/A	DWS Contrast?	N/A
N/A	Landing Slope (%)	N/A	N/A	DWS Length (in)	N/A
N/A	Landing X Slope (%)	N/A	N/A	DWS Full Width?	N/A
N/A	Landing Curb? (Y/N)	N/A	N/A	DWS Offset (in)	N/A
N/A	Shared Landing?	N/A			
N/A	Gutter Ponding?	N/A	N/A	Gutter Slope (%)	N/A
N/A	Gutter Lip Ht (in)	N/A	N/A	Gutter X Slope (%)	N/A
N/A	Painted X Walk1?	No	N/A	Painted X Walk2?	N/A
	X Walk 1 Direction	To NW		X Walk 2 Direction	N/A
N/A	X Walk 1 Width (in)	N/A	N/A	X Walk 2 Width (in)	N/A
	X Walk 1 Slope (%)	3.8		X Walk 2 Slope (%)	N/A
	X Walk 1 X Slope (%)	2.6		X Walk 2 X Slope (%)	N/A

N/A	Ramp inside XWalk1?	N/A	N/A	Ramp inside XWalk2?	N/A
	Road Slope (%)	N/A	N/A	Clear Space?	N/A
	Road X Slope (%)	N/A	N/A	Clear Space to XWalk (in)	N/A
N/A	Any Obstructions?	N/A	N/A	Storm Grate/Utility Hazard?	N/A
	Obstruction Type			Storm Grate/Utility Type	
		N/A			N/A
			Yes	Surface Condition? (G/P)	Good

Remove & Replace Entire Ramp.
