Access Compliance Report Public Rights-of-Way (Curb Ramps)

Intersection ID: 10023727Main Street: COLISEUM_CENTRE_DRCross Street: N/ALocation:NEADA ID: 338F092B81A5Ramp Type: PerpInitial Pass/Fail: FailOverall Compliance: NoSeverity Score:60

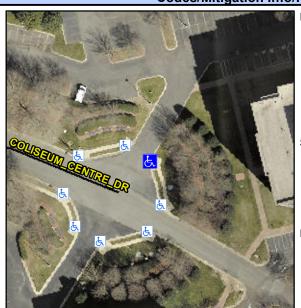
| Field Measurements/Component Compliance | | | | | | | |
|---|---|---|---|---|---|--|--|
| No | Ramp Width (in) | 31.0 | No | Ramp XSlope (%) | 18.0 | | |
