# Access Compliance Report

## Public Rights-of-Way

### (Curb Ramps)

| Intersection ID: 48583 | Main Street: STONEY_CREEK_LN | Cross Street: WATERLILY_LN | Location: SE |

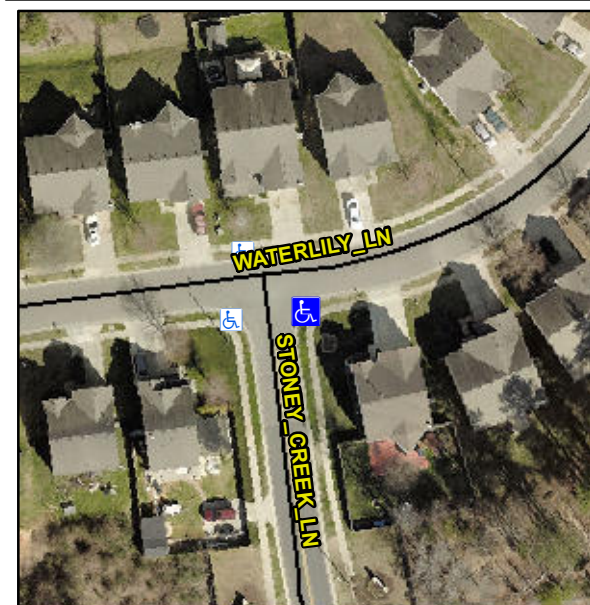
**Not Found, R304.2.1, R302.7.2, R304.5.4**

| Compliance | Description | Data | Compliance | Description | Data |
|---|---|---|---|---|---|
| No | Landing Length (in) | 47.0 | Yes | DWS Provided? | Yes |
| Yes | Gutter Ponding? | No | No | Gutter Slope (%) | 6.3 |
| No | Gutter Lip Ht (in) | 1.0 | Yes | Gutter X Slope (%) | 1.0 |

**Remove & Replace Curb Ramp With Two New Directional Ramps or Equivalent. Remove & Replace Gutter.**
