Access Compliance Report

Public Rights-of-Way

(Curb Ramps)

Intersection ID: 12235	Main Street: WICKVILLE_DR	Cross Street: MARKET_ST	Location: SE
ADA ID: 339651D0AB78	Ramp Type: Perp	Initial Pass/Fail: Fail	Overall Compliance: No
Severity Score: 21.25			
Codes/Mitigation Info/Possible Solution		Field Measurements/Component Compliance

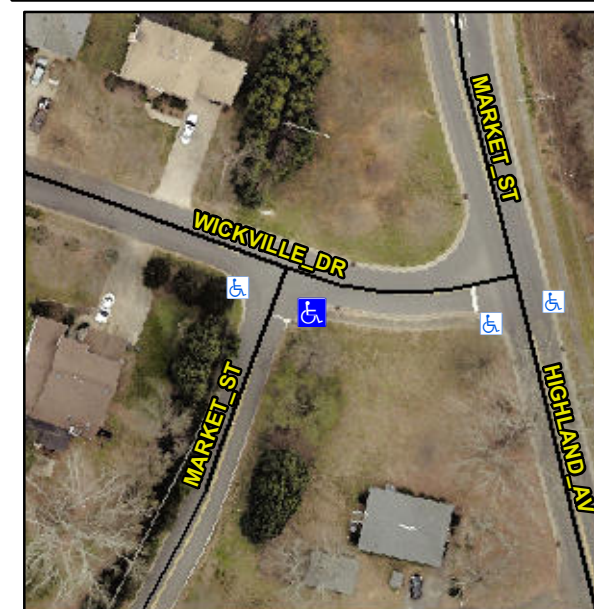
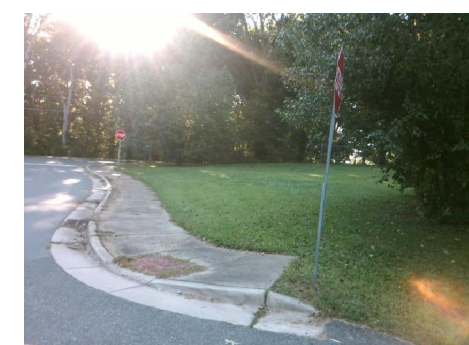
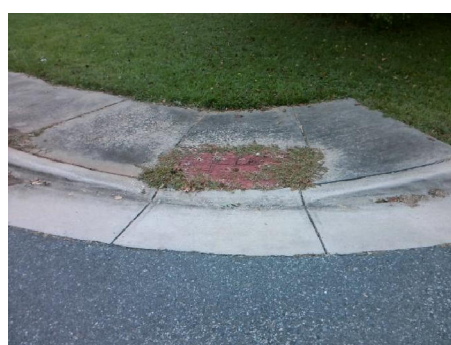
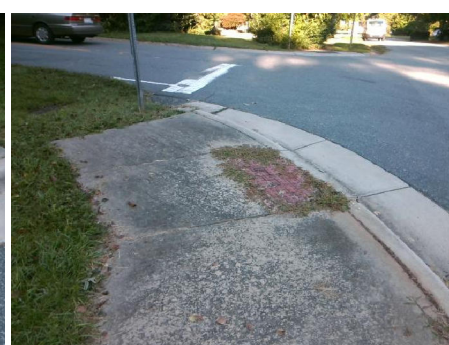
Not Found, R304.5.1, R304.5.3

Compliance	Description	Data	Compliance	Description	Data
N/A	Ramp Length (in)	76.0	Yes	Ramp Slope (%)	7.5
No	Ramp Width (in)	41.0	No	Ramp XSlope (%)	5.4
N/A	Flare Type LT	N/A	N/A	Flare Type RT	N/A
N/A	Flare Slope LT (%)	N/A	N/A	Flare Slope RT (%)	N/A
N/A	Flare Traversable LT?	N/A	N/A	Flare Traversable RT?	N/A
N/A	Landing Length (in)	N/A	N/A	DWS Provided?	N/A
N/A	Landing Width (in)	N/A	N/A	DWS Contrast?	N/A
N/A	Landing Slope (%)	N/A	N/A	DWS Length (in)	N/A
N/A	Landing X Slope (%)	N/A	N/A	DWS Full Width?	N/A
N/A	Landing Curb? (Y/N)	N/A	N/A	DWS Offset (in)	N/A
N/A	Shared Landing?	N/A			
N/A	Gutter Ponding?	N/A	N/A	Gutter Slope (%)	N/A
N/A	Gutter Lip Ht (in)	N/A	N/A	Gutter X Slope (%)	N/A
N/A	Painted X Walk1?	No	N/A	Painted X Walk2?	N/A
	X Walk 1 Direction	To NW		X Walk 2 Direction	N/A
N/A	X Walk 1 Width (in)	N/A	N/A	X Walk 2 Width (in)	N/A
	X Walk 1 Slope (%)	0.5		X Walk 2 Slope (%)	N/A
	X Walk 1 X Slope (%)	5.6		X Walk 2 X Slope (%)	N/A

N/A	Ramp inside XWalk1?	N/A	N/A	Ramp inside XWalk2?	N/A
	Road Slope (%)	N/A	N/A	Clear Space?	N/A
	Road X Slope (%)	N/A	N/A	Clear Space to XWalk (in)	N/A
N/A	Any Obstructions?	N/A	N/A	Storm Grate/Utility Hazard?	N/A
	Obstruction Type			Storm Grate/Utility Type	
		N/A			N/A
		Yes		Surface Condition? (G/P)	Good

Possible Solutions:

Remove & Replace Entire Ramp.

Total Cost: \$ 1850.00
