# Access Compliance Report

## Public Rights-of-Way

### (Curb Ramps)

Intersection ID: 10040790	Main Street: W_W_T_HARRIS_BV	Cross Street: N/A	Location: NE
ADA ID: 3397FD6DFB75	Ramp Type: Perp	Initial Pass/Fail: Fail	Overall Compliance: No
Severity Score: 1.25			
Codes/Mitigation Info/Possible Solution		Field Measurements/Component Compliance

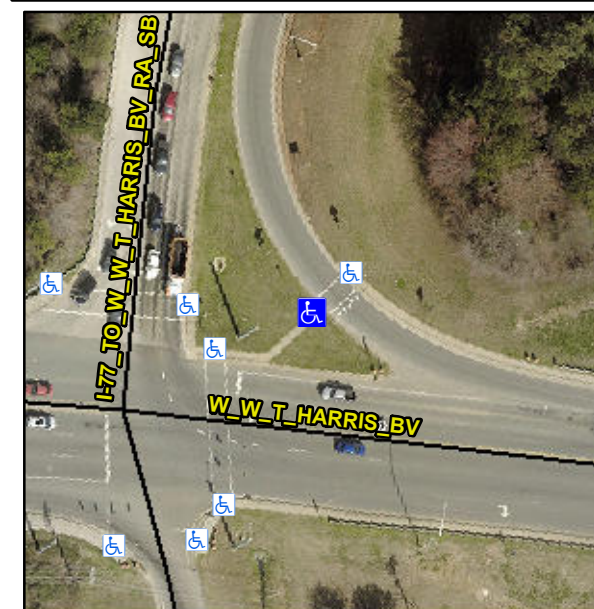
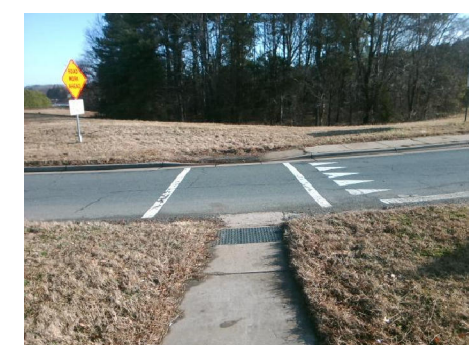
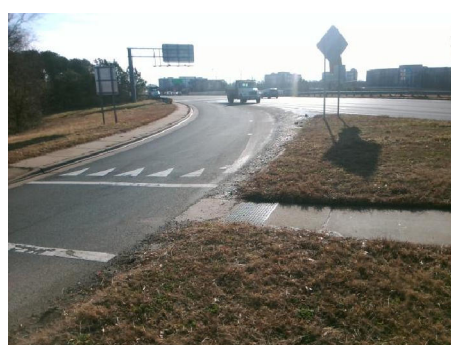
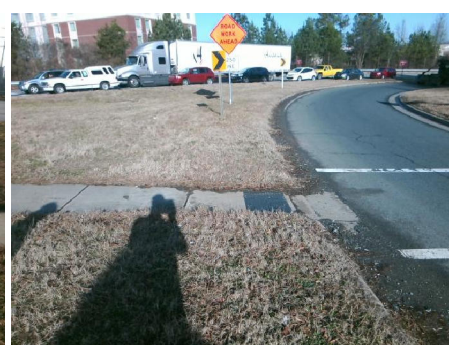
**Not Found, R304.5.3**

Compliance	Description	Data	Compliance	Description	Data
N/A	Ramp Length (in)	60.0	Yes	Ramp Slope (%)	6.7
Yes	Ramp Width (in)	53.0	No	Ramp XSlope (%)	2.9
N/A	Flare Type LT	N/A	N/A	Flare Type RT	N/A
N/A	Flare Slope LT (%)	N/A	N/A	Flare Slope RT (%)	N/A
N/A	Flare Traversable LT?	N/A	N/A	Flare Traversable RT?	N/A
N/A	Landing Length (in)	N/A	N/A	DWS Provided?	N/A
N/A	Landing Width (in)	N/A	N/A	DWS Contrast?	N/A
N/A	Landing Slope (%)	N/A	N/A	DWS Length (in)	N/A
N/A	Landing X Slope (%)	N/A	N/A	DWS Full Width?	N/A
N/A	Landing Curb? (Y/N)	N/A	N/A	DWS Offset (in)	N/A
N/A	Shared Landing?	N/A			
N/A	Gutter Ponding?	N/A	N/A	Gutter Slope (%)	N/A
N/A	Gutter Lip Ht (in)	N/A	N/A	Gutter X Slope (%)	N/A
N/A	Painted X Walk1?	Yes	N/A	Painted X Walk2?	N/A
	X Walk 1 Direction	To NE		X Walk 2 Direction	N/A
N/A	X Walk 1 Width (in)	118.0	N/A	X Walk 2 Width (in)	N/A
	X Walk 1 Slope (%)	0.5		X Walk 2 Slope (%)	N/A
	X Walk 1 X Slope (%)	2.1		X Walk 2 X Slope (%)	N/A

N/A	Ramp inside XWalk1?	Yes	N/A	Ramp inside XWalk2?	N/A
	Road Slope (%)	N/A	N/A	Clear Space?	N/A
	Road X Slope (%)	N/A	N/A	Clear Space to XWalk (in)	N/A
N/A	Any Obstructions?	N/A	N/A	Storm Grate/Utility Hazard?	N/A
	Obstruction Type			Storm Grate/Utility Type	
		N/A			N/A
		Yes		Surface Condition? (G/P)	Good

**Remove & Replace Entire Ramp.**

\$ 1850.00
