Access Compliance Report

Public Rights-of-Way

(Curb Ramps)

Intersection ID: 15303	Main Street: IDEAL_WY	Cross Street: MCDONALD_AV	Location: SW
ADA ID: 339EB504694A	Ramp Type: PerpDiag	Initial Pass/Fail: Fail	Overall Compliance: No
		Severity Score: 25

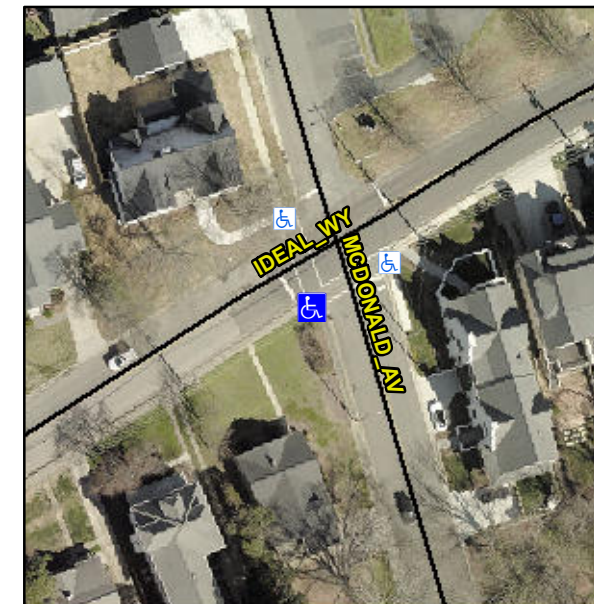
Not Found, R304.5.3

Compliance	Description	Data	Compliance	Description	Data
N/A	Ramp Length (in)	44.0	Yes	Ramp Slope (%)	7.6
Yes	Ramp Width (in)	48.0	No	Ramp XSlope (%)	15.2
N/A	Flare Type LT	N/A	N/A	Flare Type RT	N/A
N/A	Flare Slope LT (%)	N/A	N/A	Flare Slope RT (%)	N/A
N/A	Flare Traversable LT?	N/A	N/A	Flare Traversable RT?	N/A
N/A	Landing Length (in)	N/A	N/A	DWS Provided?	N/A
N/A	Landing Width (in)	N/A	N/A	DWS Contrast?	N/A
N/A	Landing Slope (%)	N/A	N/A	DWS Length (in)	N/A
N/A	Landing X Slope (%)	N/A	N/A	DWS Full Width?	N/A
N/A	Landing Curb? (Y/N)	N/A	N/A	DWS Offset (in)	N/A
N/A	Shared Landing?	N/A			
N/A	Gutter Ponding?	N/A	N/A	Gutter Slope (%)	N/A
N/A	Gutter Lip Ht (in)	1.0	N/A	Gutter X Slope (%)	N/A
N/A	Painted X Walk1?	No	N/A	Painted X Walk2?	No
	X Walk 1 Direction	To NE		X Walk 2 Direction	To N
N/A	X Walk 1 Width (in)	N/A	N/A	X Walk 2 Width (in)	N/A
	X Walk 1 Slope (%)	0.8		X Walk 2 Slope (%)	9.0
	X Walk 1 X Slope (%)	10.1		X Walk 2 X Slope (%)	1.3

N/A	Ramp inside XWalk1?	N/A	N/A	Ramp inside XWalk2?	N/A
	Road Slope (%)	9.1	N/A	Clear Space?	N/A
	Road X Slope (%)	10.1	N/A	Clear Space to XWalk (in)	N/A
N/A	Any Obstructions?	N/A	N/A	Storm Grate/Utility Hazard?	N/A
	Obstruction Type			Storm Grate/Utility Type	
		N/A			N/A
			Yes	Surface Condition? (G/P)	Good

Remove & Replace Curb Ramp With Two New Directional Ramps or Equivalent.
