## Access Compliance Report Public Rights-of-Way (Curb Ramps)

Intersection ID: N/A Main Street: MOONLIGHT\_BAY\_WY Cross Street: STRAWBERRY\_FIELDS\_LN Location: SE

ADA ID: 33A0DF33C6D4 Ramp Type: Perp Initial Pass/Fail: Fail Overall Compliance: No Severity Score: 12.5

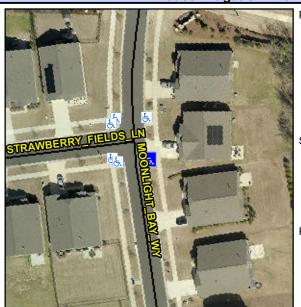
Field Measurements/Component Compliance							
	Compliance Description		Data	Compliance Description		Data	
	N/A	Ramp Length (in)	95.0	Yes	Ramp Slope (%)	5.6	
	Yes	Ramp Width (in)	48.0	No	Ramp XSlope (%)	5.8	
	N/A	Flare Type LT	N/A	N/A	Flare Type RT	N/A	
	N/A	Flare Slope LT (%)	N/A	N/A	Flare Slope RT (%)	N/A	
	N/A	Flare Traversable LT?	N/A	N/A	Flare Traversable RT?	N/A	
	N/A	Landing Length (in)	N/A	N/A	DWS Provided?	N/A	
	N/A	Landing Width (in)	N/A	N/A	DWS Contrast?	N/A	
	N/A	Landing Slope (%)	N/A	N/A	DWS Length (in)	N/A	
	N/A	Landing X Slope (%)	N/A	N/A	DWS Full Width?	N/A	
	N/A	Landing Curb? (Y/N)	N/A	N/A	DWS Offset (in)	N/A	
	N/A	Shared Landing?	N/A				
	N/A	Gutter Ponding?	N/A	N/A	Gutter Slope (%)	N/A	
	N/A	Gutter Lip Ht (in)	N/A	N/A	Gutter X Slope (%)	N/A	
	N/A	Painted X Walk1?	No	N/A	Painted X Walk2?	N/A	
		X Walk 1 Direction	To W		X Walk 2 Direction	N/A	
	N/A	X Walk 1 Width (in)	N/A	N/A	X Walk 2 Width (in)	N/A

X Walk 1 Slope (%)	2.0		X Walk 2 Slope (%)	N/A	
		X Walk 1 X Slope (%)	3.4		X Walk 2 X Slope (%)	N/A	
	N/A	Ramp inside XWalk1?	N/A	N/A	Ramp inside XWalk2?	N/A	
		Road Slope (%)	N/A	N/A	Clear Space?	N/A	
		Road X Slope (%)	N/A	N/A	Clear Space to XWalk (in)	N/A	
	N/A	Any Obstructions?	N/A	N/A	Storm Grate/Utility Hazard?	N/A	
		Obstruction Type			Storm Grate/Utility Type		
			N/A			N/A	
				Yes	Surface Condition? (G/P)	Good	
_

Possible Solutions:					
Remove & Replace Entire Ramp.					
Surveyor Notes:					
N/A					
PROW/ADA:					
R304.5.3					
•
