Access Compliance Report

Public Rights-of-Way

(Curb Ramps)

Intersection ID: 53883	Main Street: PAW_VILLAGE_RD	Cross Street: PAW_CLUB_DR	Location: E
ADA ID: 33A7932495DD	Ramp Type: PerpDiag	Initial Pass/Fail: Fail	Overall Compliance: No
Severity Score: 8.75			
Codes/Mitigation Info/Possible Solution		Field Measurements/Component Compliance

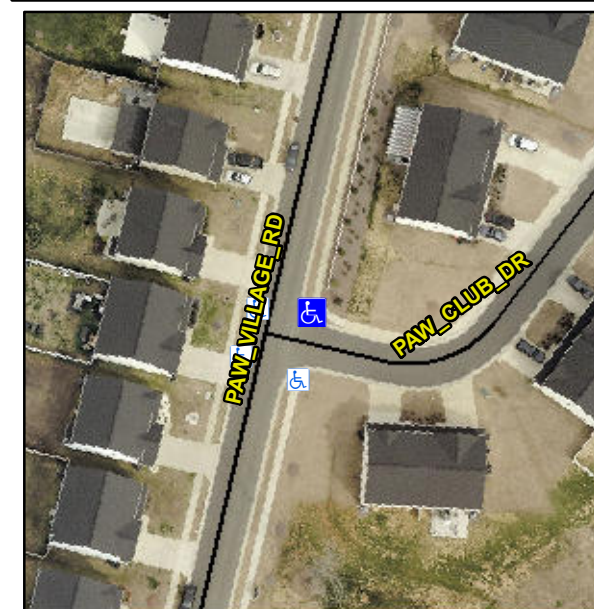
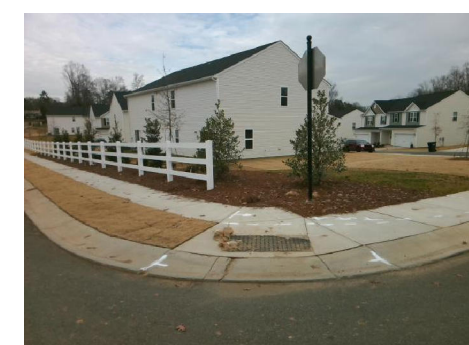
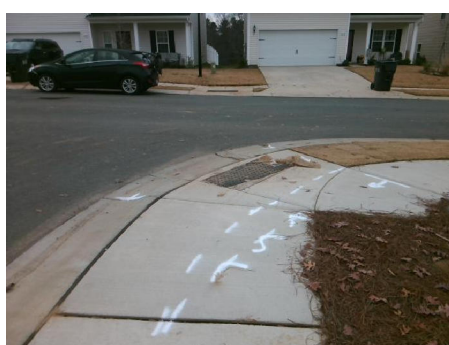
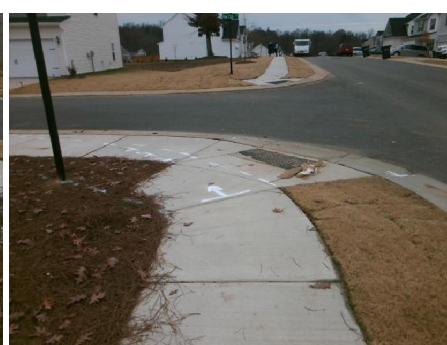
Not Found, R304.5.1

Compliance	Description	Data	Compliance	Description	Data
N/A	Ramp Length (in)	53.5	Yes	Ramp Slope (%)	5.8
No	Ramp Width (in)	47.5	Yes	Ramp XSlope (%)	0.6
N/A	Flare Type LT	N/A	N/A	Flare Type RT	N/A
N/A	Flare Slope LT (%)	N/A	N/A	Flare Slope RT (%)	N/A
N/A	Flare Traversable LT?	N/A	N/A	Flare Traversable RT?	N/A
N/A	Landing Length (in)	N/A	N/A	DWS Provided?	N/A
N/A	Landing Width (in)	N/A	N/A	DWS Contrast?	N/A
N/A	Landing Slope (%)	N/A	N/A	DWS Length (in)	N/A
N/A	Landing X Slope (%)	N/A	N/A	DWS Full Width?	N/A
N/A	Landing Curb? (Y/N)	N/A	N/A	DWS Offset (in)	N/A
N/A	Shared Landing?	N/A			
N/A	Gutter Ponding?	N/A	N/A	Gutter Slope (%)	N/A
N/A	Gutter Lip Ht (in)	N/A	N/A	Gutter X Slope (%)	N/A
N/A	Painted X Walk1?	No	N/A	Painted X Walk2?	No
	X Walk 1 Direction	To NW		X Walk 2 Direction	To SW
N/A	X Walk 1 Width (in)	N/A	N/A	X Walk 2 Width (in)	N/A
	X Walk 1 Slope (%)	4.0		X Walk 2 Slope (%)	4.6
	X Walk 1 X Slope (%)	4.2		X Walk 2 X Slope (%)	1.0

N/A	Ramp inside XWalk1?	N/A	N/A	Ramp inside XWalk2?	N/A
	Road Slope (%)	1.2	N/A	Clear Space?	N/A
	Road X Slope (%)	6.0	N/A	Clear Space to XWalk (in)	N/A
N/A	Any Obstructions?	N/A	N/A	Storm Grate/Utility Hazard?	N/A
	Obstruction Type			Storm Grate/Utility Type	
		N/A			N/A
		Yes		Surface Condition? (G/P)	Good

Remove & Replace Curb Ramp With Two New Directional Ramps or Equivalent.
