# Access Compliance Report

## Public Rights-of-Way

### (Curb Ramps)

Intersection ID: 10014838	Main Street: THE_PLAZA	Cross Street: N/A	Location: NE
ADA ID: 33A9C4B453A0	Ramp Type: Perp	Initial Pass/Fail: Fail	Overall Compliance: No
		Severity Score: 12.5

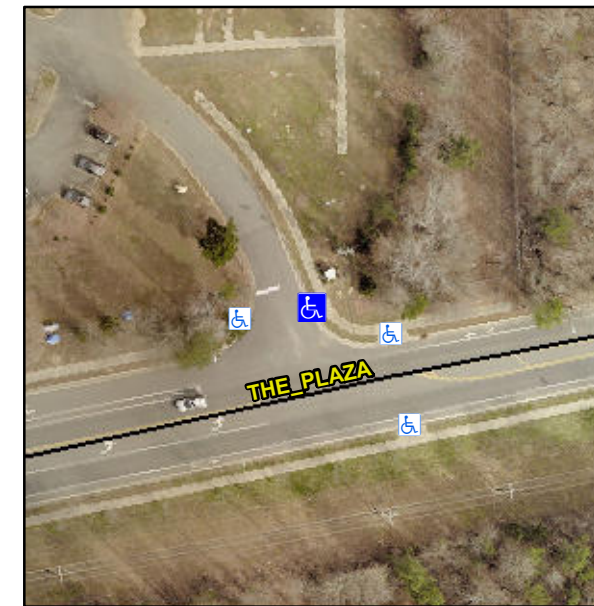
**Not Found, R304.5.3**

Compliance	Description	Data	Compliance	Description	Data
N/A	Ramp Length (in)	47.0	Yes	Ramp Slope (%)	5.9
Yes	Ramp Width (in)	48.0	No	Ramp XSlope (%)	6.4
N/A	Flare Type LT	N/A	N/A	Flare Type RT	N/A
N/A	Flare Slope LT (%)	N/A	N/A	Flare Slope RT (%)	N/A
N/A	Flare Traversable LT?	N/A	N/A	Flare Traversable RT?	N/A
N/A	Landing Length (in)	N/A	N/A	DWS Provided?	N/A
N/A	Landing Width (in)	N/A	N/A	DWS Contrast?	N/A
N/A	Landing Slope (%)	N/A	N/A	DWS Length (in)	N/A
N/A	Landing X Slope (%)	N/A	N/A	DWS Full Width?	N/A
N/A	Landing Curb? (Y/N)	N/A	N/A	DWS Offset (in)	N/A
N/A	Shared Landing?	N/A			
N/A	Gutter Ponding?	N/A	N/A	Gutter Slope (%)	N/A
N/A	Gutter Lip Ht (in)	N/A	N/A	Gutter X Slope (%)	N/A
N/A	Painted X Walk1?	No	N/A	Painted X Walk2?	N/A
	X Walk 1 Direction	To W		X Walk 2 Direction	N/A
N/A	X Walk 1 Width (in)	N/A	N/A	X Walk 2 Width (in)	N/A
	X Walk 1 Slope (%)	0.4		X Walk 2 Slope (%)	N/A
	X Walk 1 X Slope (%)	1.4		X Walk 2 X Slope (%)	N/A

**Remove & Replace Entire Ramp.**
