Access Compliance Report

Public Rights-of-Way

(Curb Ramps)

| Intersection ID: 48767 | Main Street: TURNING_WHEEL_DR | Cross Street: MINITREE_LN | Location: SW |

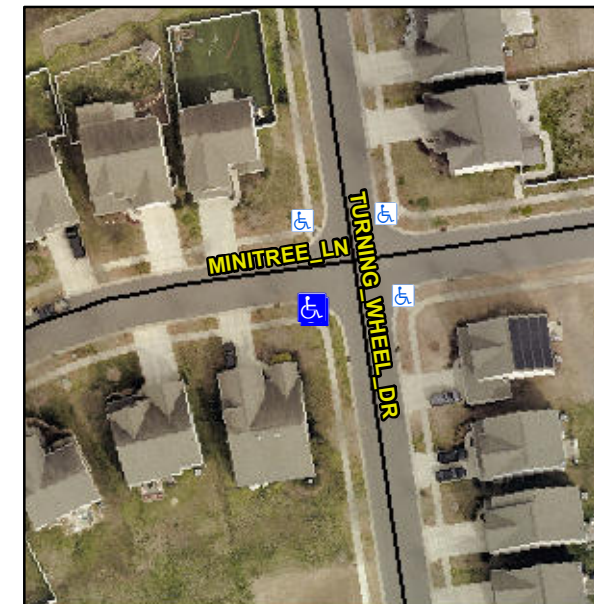
| ADA ID: 33AAF4D76B86 | Ramp Type: PerpDiag | Initial Pass/Fail: Fail | Overall Compliance: No |
| Severity Score: 8.75 | | | |

R304.5.1

| Compliance | Description | Data | Compliance | Description | Data |
|---|---|---|---|---|---|
| No | Ramp Width (in) | 47.0 | Yes | Ramp XSlope (%) | 1.5 |

Remove & Replace Curb Ramp With Two New Directional Ramps or Equivalent.
