## Access Compliance Report Public Rights-of-Way (Curb Ramps)

Intersection ID: 20146Main Street: FAIRVIEW\_RDCross Street: PARK\_SOUTH\_DRLocation:NWADA ID: 33AAF91FA13CRamp Type: ParaInitial Pass/Fail: FailOverall Compliance: NoSeverity Score: 13.75

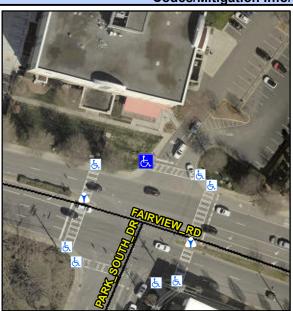
Field Measurements/Component Compliance							
Compliance Description		Data	Comp	liance Description	Data		
N/A	Ramp Length LT (in)	84.0	N/A	Ramp Length RT (in)	76.		
Yes	Ramp Width LT (in)	60.0	Yes	Ramp Width RT (in)	60.		
No	Ramp Slope LT (%)	11.4	Yes	Ramp Slope RT (%)	1.1		
No	Ramp XSlope LT (%)	2.1	Yes	Ramp XSlope RT (%)	1.3		
N/A	Landing Length (in)	N/A	N/A	DWS Provided?	N/A		
N/A	Landing Width (in)	N/A	N/A	DWS Contrast?	N/A		
N/A	Landing Slope (%)	N/A	N/A	DWS Length (in)	N/A		
N/A	Landing X Slope (%)	N/A	N/A	DWS Full Width?	N/A		
N/A	Landing Curb? (Y/N)	N/A	N/A	DWS Offset (in)	N/A		
N/A	Shared Landing?	N/A					
N/A	Gutter Ponding?	N/A	N/A	Gutter Slope (%)	N/A		
N/A	Gutter Lip Ht (in)	N/A	N/A	Gutter X Slope (%)	N/A		
N/A	Painted X Walk1?	Yes	N/A	Painted X Walk2?	N/A		
	X Walk 1 Direction	To E		X Walk 2 Direction	N/A		
N/A	X Walk 1 Width (in)	82.0	N/A	X Walk 2 Width (in)	N/A		
	X Walk 1 Slope (%)	1.1		X Walk 2 Slope (%)	N/A

X Walk 1 X Slope (%)	4.6		X Walk 2 X Slope (%)	N/A		
N/A	Ramp inside XWalk1?	Yes	N/A	Ramp inside XWalk2?	N/A		
	Road Slope (%)	N/A	N/A	Clear Space?	N/A		
	Road X Slope (%)	N/A	N/A	Clear Space to XWalk (in)	N/A		
N/A	Any Obstructions?	N/A	N/A	Storm Grate/Utility Hazard?	N/A		
	Obstruction Type			Storm Grate/Utility Type			
		N/A			N/A		
			Yes	Surface Condition? (G/P)	Good		
			N/A	Curb Slope (%)	0.		
112

Possible Solutions:	Co
Remove & Replace Entire Ramp.	N/A
·	Yes
	No
	No
	N/A
	N/A
Surveyor Notes:	N/A
RT RP < 5%	N/A
	N/A
	N/A
	N/A
PROW/ADA:	N/A
R304.3.2, R304.5.3	N/A
	N/A
	N/A
