Access Compliance Report Public Rights-of-Way (Curb Ramps)

Intersection ID: 12299 Main Street: W MOREHEAD ST Cross Street: S CHASE ST Location: N Initial Pass/Fail: Fail **Overall Compliance: No Severity Score:** 25 ADA ID: 33ACFAA82F98 Ramp Type: PerpDiag

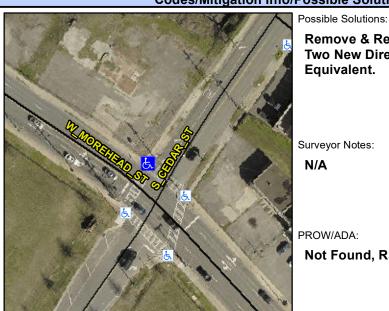
Not Found, R304.5.3

No Ramp XSlope (%) Yes Ramp Width (in) 48.0 N/A N/A Flare Type LT N/A Flare Type RT N/A N/A N/A Flare Slope RT (%) Flare Slope LT (%) N/A Flare Traversable LT? N/A N/A Flare Traversable RT? N/A N/A N/A **DWS Provided?** Landing Length (in) N/A Landing Width (in) N/A N/A **DWS Contrast?** N/A N/A N/A Landing Slope (%) DWS Length (in) N/A Landing X Slope (%) N/A N/A DWS Full Width? N/A Landing Curb? (Y/N) N/A N/A DWS Offset (in) N/A N/A Shared Landing? N/A **Gutter Ponding?** N/A N/A Gutter Slope (%) N/A Gutter Lip Ht (in) N/A N/A Gutter X Slope (%) N/A Painted X Walk1? Yes N/A Painted X Walk2? X Walk 1 Direction To SW X Walk 2 Direction N/A 105.0 X Walk 1 Width (in) X Walk 2 Width (in) X Walk 1 Slope (%) X Walk 2 Slope (%) 6.4 X Walk 1 X Slope (%) 4.9 X Walk 2 X Slope (%) N/A N/A Ramp inside XWalk2? Ramp inside XWalk1? Yes Road Slope (%) 0.2 N/A Clear Space? N/A Road X Slope (%) 10.7 Clear Space to XWalk (in) N/A N/A Any Obstructions? N/A Storm Grate/Utility Hazard? **Obstruction Type** Storm Grate/Utility Type

Remove & Replace Curb Ramp With Two New Directional Ramps or Equivalent.
