# Access Compliance Report

## Public Rights-of-Way

### (Curb Ramps)

Intersection ID: 10019873	Main Street: ARCHDALE_DR	Cross Street: N/A	Location:	N
ADA ID: 33CA0DDE5202	Ramp Type: PerpDiag	Initial Pass/Fail: Fail	Overall Compliance: No	Severity Score: 26.25

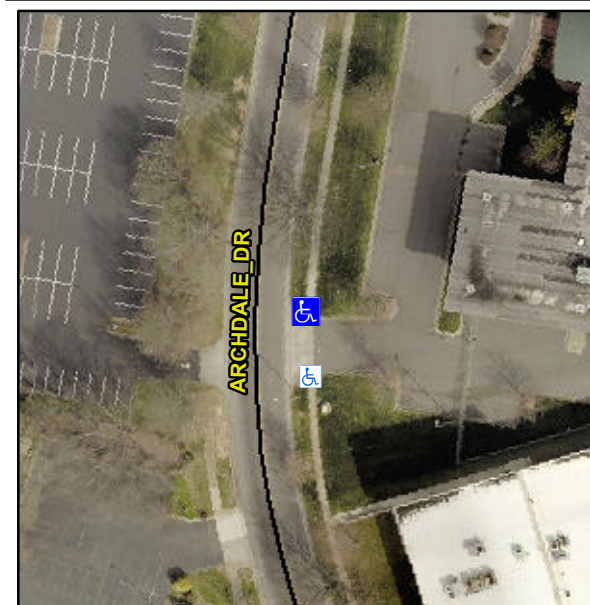
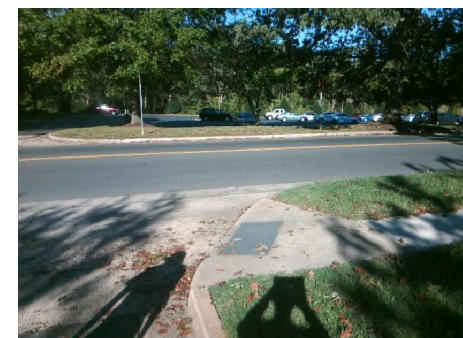
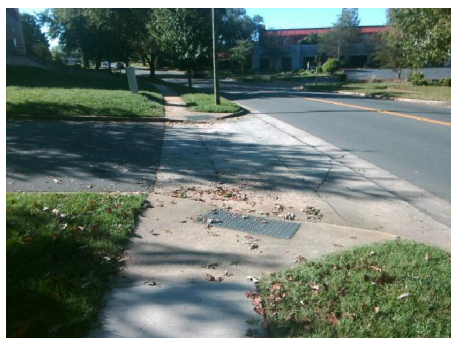
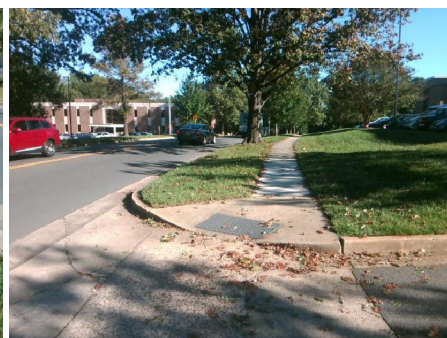
**Not Found, R304.2.2**

Compliance	Description	Data	Compliance	Description	Data
N/A	Ramp Length (in)	69.0	No	Ramp Slope (%)	14.8
Yes	Ramp Width (in)	48.0	Yes	Ramp XSlope (%)	2.1
N/A	Flare Type LT	N/A	N/A	Flare Type RT	N/A
N/A	Flare Slope LT (%)	N/A	N/A	Flare Slope RT (%)	N/A
N/A	Flare Traversable LT?	N/A	N/A	Flare Traversable RT?	N/A
N/A	Landing Length (in)	N/A	N/A	DWS Provided?	N/A
N/A	Landing Width (in)	N/A	N/A	DWS Contrast?	N/A
N/A	Landing Slope (%)	N/A	N/A	DWS Length (in)	N/A
N/A	Landing X Slope (%)	N/A	N/A	DWS Full Width?	N/A
N/A	Landing Curb? (Y/N)	N/A	N/A	DWS Offset (in)	N/A
N/A	Shared Landing?	N/A			
N/A	Gutter Ponding?	N/A	N/A	Gutter Slope (%)	N/A
N/A	Gutter Lip Ht (in)	N/A	N/A	Gutter X Slope (%)	N/A
N/A	Painted X Walk1?	No	N/A	Painted X Walk2?	No
	X Walk 1 Direction	To W		X Walk 2 Direction	To S
N/A	X Walk 1 Width (in)	N/A	N/A	X Walk 2 Width (in)	N/A
	X Walk 1 Slope (%)	1.9		X Walk 2 Slope (%)	2.4
	X Walk 1 X Slope (%)	0.3		X Walk 2 X Slope (%)	2.3

N/A	Ramp inside XWalk1?	N/A	N/A	Ramp inside XWalk2?	N/A
	Road Slope (%)	3.2	N/A	Clear Space?	N/A
	Road X Slope (%)	1.5	N/A	Clear Space to XWalk (in)	N/A
N/A	Any Obstructions?	N/A	N/A	Storm Grate/Utility Hazard?	N/A
	Obstruction Type			Storm Grate/Utility Type	
		N/A			N/A
			Yes	Surface Condition? (G/P)	Good

**Remove & Replace Curb Ramp With Two New Directional Ramps or Equivalent.**
