Access Compliance Report

Public Rights-of-Way (Curb Ramps)

Intersection ID: 4480	Main Street: KEMPSFORD_DR	Cross Street: SILVER_GLEN_LN	Location: NE
ADA ID: 33D563F84BC2	Ramp Type: PerpDiag	Initial Pass/Fail: Fail	Overall Compliance: No
Severity Score: 33.75			
Codes/Mitigation Info/Possible Solution		Field Measurements/Component Compliance

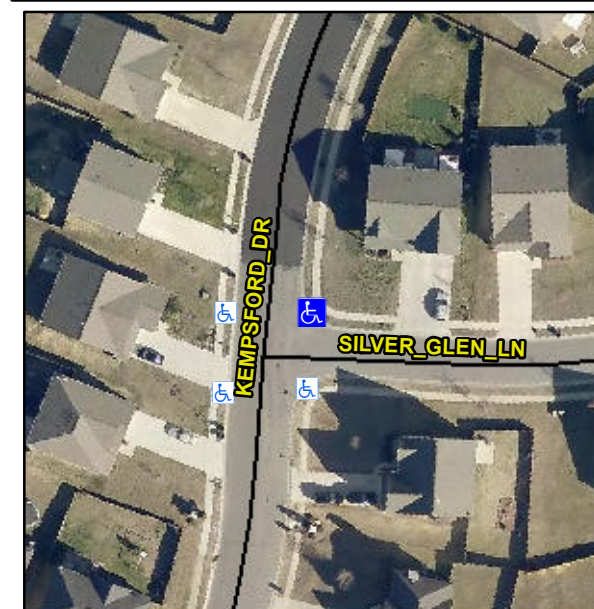
Not Found, R304.5.1, R304.2.2, R304.5.3

Compliance	Description	Data	Compliance	Description	Data
N/A	Ramp Length (in)	48.0	No	Ramp Slope (%)	9.2
No	Ramp Width (in)	46.0	No	Ramp XSlope (%)	5.2
N/A	Flare Type LT	N/A	N/A	Flare Type RT	N/A
N/A	Flare Slope LT (%)	N/A	N/A	Flare Slope RT (%)	N/A
N/A	Flare Traversable LT?	N/A	N/A	Flare Traversable RT?	N/A
N/A	Landing Length (in)	N/A	N/A	DWS Provided?	N/A
N/A	Landing Width (in)	N/A	N/A	DWS Contrast?	N/A
N/A	Landing Slope (%)	N/A	N/A	DWS Length (in)	N/A
N/A	Landing X Slope (%)	N/A	N/A	DWS Full Width?	N/A
N/A	Landing Curb? (Y/N)	N/A	N/A	DWS Offset (in)	N/A
N/A	Shared Landing?	N/A			
N/A	Gutter Ponding?	N/A	N/A	Gutter Slope (%)	N/A
N/A	Gutter Lip Ht (in)	N/A	N/A	Gutter X Slope (%)	N/A
N/A	Painted X Walk1?	No	N/A	Painted X Walk2?	No
	X Walk 1 Direction	To W		X Walk 2 Direction	To S
N/A	X Walk 1 Width (in)	N/A	N/A	X Walk 2 Width (in)	N/A
	X Walk 1 Slope (%)	4.4		X Walk 2 Slope (%)	1.7
	X Walk 1 X Slope (%)	2.4		X Walk 2 X Slope (%)	3.5

N/A	Ramp inside XWalk1?	N/A	N/A	Ramp inside XWalk2?	N/A
	Road Slope (%)	2.8	N/A	Clear Space?	N/A
	Road X Slope (%)	2.3	N/A	Clear Space to XWalk (in)	N/A
N/A	Any Obstructions?	N/A	N/A	Storm Grate/Utility Hazard?	N/A
	Obstruction Type			Storm Grate/Utility Type	
		N/A			N/A
		Yes		Surface Condition? (G/P)	Good

Remove & Replace Curb Ramp With Two New Directional Ramps or Equivalent.
