Access Compliance Report

Public Rights-of-Way

(Curb Ramps)

Intersection ID: 25129	Main Street: BROOKNELL_TR	Cross Street: WINDING_OAK_DR	Location: SE
ADA ID: 33D9B95E84F0	Ramp Type: PerpDiag	Initial Pass/Fail: Fail	Overall Compliance: No
		Severity Score: 12.5

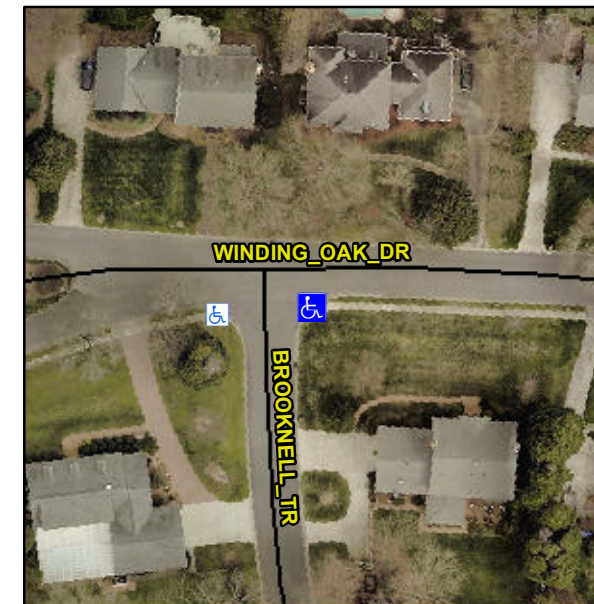
Not Found, R304.2.2

Compliance	Description	Data	Compliance	Description	Data
N/A	Ramp Length (in)	48.0	No	Ramp Slope (%)	10.2
Yes	Ramp Width (in)	48.0	Yes	Ramp XSlope (%)	1.9
N/A	Flare Type LT	N/A	N/A	Flare Type RT	N/A
N/A	Flare Slope LT (%)	N/A	N/A	Flare Slope RT (%)	N/A
N/A	Flare Traversable LT?	N/A	N/A	Flare Traversable RT?	N/A
N/A	Landing Length (in)	N/A	N/A	DWS Provided?	N/A
N/A	Landing Width (in)	N/A	N/A	DWS Contrast?	N/A
N/A	Landing Slope (%)	N/A	N/A	DWS Length (in)	N/A
N/A	Landing X Slope (%)	N/A	N/A	DWS Full Width?	N/A
N/A	Landing Curb? (Y/N)	N/A	N/A	DWS Offset (in)	N/A
N/A	Shared Landing?	N/A			
N/A	Gutter Ponding?	N/A	N/A	Gutter Slope (%)	N/A
N/A	Gutter Lip Ht (in)	N/A	N/A	Gutter X Slope (%)	N/A
N/A	Painted X Walk1?	No	N/A	Painted X Walk2?	No
	X Walk 1 Direction	To N		X Walk 2 Direction	To W
N/A	X Walk 1 Width (in)	N/A	N/A	X Walk 2 Width (in)	N/A
	X Walk 1 Slope (%)	1.6		X Walk 2 Slope (%)	0.9
	X Walk 1 X Slope (%)	0.2		X Walk 2 X Slope (%)	1.9

N/A	Ramp inside XWalk1?	N/A	N/A	Ramp inside XWalk2?	N/A
	Road Slope (%)	1.3	N/A	Clear Space?	N/A
	Road X Slope (%)	4.4	N/A	Clear Space to XWalk (in)	N/A
N/A	Any Obstructions?	N/A	N/A	Storm Grate/Utility Hazard?	N/A
	Obstruction Type			Storm Grate/Utility Type	
		N/A			N/A
			Yes	Surface Condition? (G/P)	Good

Remove & Replace Curb Ramp With Two New Directional Ramps or Equivalent.

Total Cost: \$ 3200.00
