Access Compliance Report Public Rights-of-Way (Curb Ramps)

Intersection ID: 4753 Main Street: LOWEN_RD Cross Street: SADDLE_TRAIL_LN Location: SW

ADA ID: 33DE60C9EDED Ramp Type: Perp Initial Pass/Fail: Fail Overall Compliance: No Severity Score: 46.25

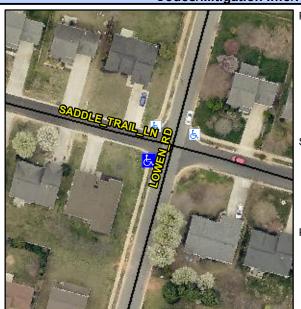
Possible Solutions:
Remove & Replace Entire Ramp.
Surveyor Notes: N/A
PROW/ADA: Not Found, R304.5.1, R304.2.2, R304.5.3

Field Measurements/Component Compliance							
	Compliance Description		Data	Compliance Description		Data	
	N/A	Ramp Length (in)	46.0	No	Ramp Slope (%)	9.2	
	No	Ramp Width (in)	43.0	No	Ramp XSlope (%)	11.1	
	N/A	Flare Type LT	N/A	N/A	Flare Type RT	N/A	
	N/A	Flare Slope LT (%)	N/A	N/A	Flare Slope RT (%)	N/A	
	N/A	Flare Traversable LT?	N/A	N/A	Flare Traversable RT?	N/A	
	N/A	Landing Length (in)	N/A	N/A	DWS Provided?	N/A	
	N/A	Landing Width (in)	N/A	N/A	DWS Contrast?	N/A	
	N/A	Landing Slope (%)	N/A	N/A	DWS Length (in)	N/A	
	N/A	Landing X Slope (%)	N/A	N/A	DWS Full Width?	N/A	
	N/A	Landing Curb? (Y/N)	N/A	N/A	DWS Offset (in)	N/A	
	N/A	Shared Landing?	N/A				
	N/A	Gutter Ponding?	N/A	N/A	Gutter Slope (%)	N/A	
	N/A	Gutter Lip Ht (in)	N/A	N/A	Gutter X Slope (%)	N/A	
	N/A	Painted X Walk1?	No	N/A	Painted X Walk2?	N/A	
		X Walk 1 Direction	To NE		X Walk 2 Direction	N/A	
	N/A	X Walk 1 Width (in)	N/A	N/A	X Walk 2 Width (in)	N/A

X Walk 1 Slope (%)	1.7		X Walk 2 Slope (%)	N/A	
		X Walk 1 X Slope (%)	8.5		X Walk 2 X Slope (%)	N/A	
	N/A	Ramp inside XWalk1?	N/A	N/A	Ramp inside XWalk2?	N/A	
		Road Slope (%)	N/A	N/A	Clear Space?	N/A	
		Road X Slope (%)	N/A	N/A	Clear Space to XWalk (in)	N/A	
	N/A	Any Obstructions?	N/A	N/A	Storm Grate/Utility Hazard?	N/A	
		Obstruction Type			Storm Grate/Utility Type		
			N/A			N/A	
				Yes	Surface Condition? (G/P)	Good	
	Maritania	LIV. V
