Access Compliance Report

Public Rights-of-Way

(Curb Ramps)

Intersection ID: 10027413	Main Street: GOLF_LINKS_DR_N	Cross Street: N/A	Location: SW
ADA ID: 33F3C43B19E5	Ramp Type: Perp	Initial Pass/Fail: Fail	Overall Compliance: No
		Severity Score: 12.5

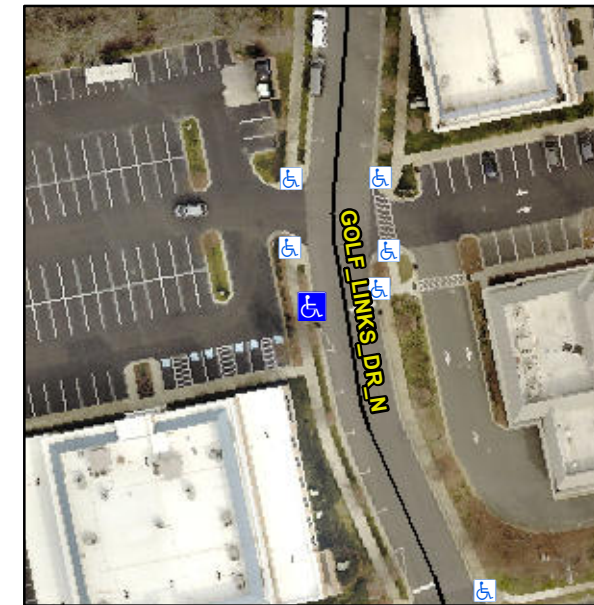
Not Found, R304.2.2

Compliance	Description	Data	Compliance	Description	Data
N/A	Ramp Length (in)	48.0	No	Ramp Slope (%)	10.7
Yes	Ramp Width (in)	60.0	Yes	Ramp XSlope (%)	0.7
N/A	Flare Type LT	N/A	N/A	Flare Type RT	N/A
N/A	Flare Slope LT (%)	N/A	N/A	Flare Slope RT (%)	N/A
N/A	Flare Traversable LT?	N/A	N/A	Flare Traversable RT?	N/A
N/A	Landing Length (in)	N/A	N/A	DWS Provided?	N/A
N/A	Landing Width (in)	N/A	N/A	DWS Contrast?	N/A
N/A	Landing Slope (%)	N/A	N/A	DWS Length (in)	N/A
N/A	Landing X Slope (%)	N/A	N/A	DWS Full Width?	N/A
N/A	Landing Curb? (Y/N)	N/A	N/A	DWS Offset (in)	N/A
N/A	Shared Landing?	N/A			
N/A	Gutter Ponding?	N/A	N/A	Gutter Slope (%)	N/A
N/A	Gutter Lip Ht (in)	N/A	N/A	Gutter X Slope (%)	N/A
N/A	Painted X Walk1?	No	N/A	Painted X Walk2?	N/A
	X Walk 1 Direction	To E		X Walk 2 Direction	N/A
N/A	X Walk 1 Width (in)	N/A	N/A	X Walk 2 Width (in)	N/A
	X Walk 1 Slope (%)	2.8		X Walk 2 Slope (%)	N/A
	X Walk 1 X Slope (%)	1.4		X Walk 2 X Slope (%)	N/A

Possible Solutions:

Remove & Replace Entire Ramp.

Total Cost: \$ 1850.00
