## **Access Compliance Report Public Rights-of-Way** (Curb Ramps)

Intersection ID: 51750 Main Street: GOLF\_LINKS\_DR\_N Cross Street: ALLISON\_WOODS\_DR Location: SE **ADA ID: 33FB0DD547A3** Ramp Type: Perp Initial Pass/Fail: Fail **Overall Compliance: No Severity Score:** 37.5

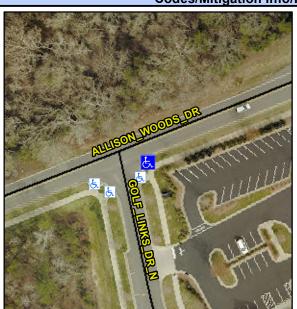
Field Measurements/Component Compliance								
Comp	liance Description	Data	Comp	liance	Description	Data		
N/A	Ramp Length (in)	120.0	No	Ramp	Slope (%)	12.2		
Yes	Ramp Width (in)	48.0	No Ramp XSlope (%)		6.2			
N/A	Flare Type LT	N/A	N/A Flare Type RT		N/A			
N/A	Flare Slope LT (%)	N/A	N/A Flare Slope RT (%)			N/A		
N/A	Flare Traversable LT?	N/A	N/A Flare Traversable RT?			N/A		
N/A	Landing Length (in)	N/A	N/A	DWS	Provided?	N/A		
N/A	Landing Width (in)	N/A	N/A	/A DWS Contrast?		N/A		
N/A	Landing Slope (%)	N/A	N/A	DWS	Length (in)	N/A		
N/A	Landing X Slope (%)	N/A	N/A	DWS	Full Width?	N/A		
N/A	Landing Curb? (Y/N)	N/A	N/A	DWS	Offset (in)	N/A		
N/A	Shared Landing?	N/A						
N/A	Gutter Ponding?	N/A	N/A	Gutte	r Slope (%)	N/A		
N/A	Gutter Lip Ht (in)	N/A	N/A	Gutte	r X Slope (%)	N/A		
N/A	Painted X Walk1?	No	N/A	Paint	ed X Walk2?	N/A		
	X Walk 1 Direction	To N		X Wa	lk 2 Direction	N/A		
N/A	X Walk 1 Width (in)	N/A	N/A	N/A X Walk 2 Width (in)		N/A

X Walk 1 Slope (%)	3.6		X Wa	lk 2 Slope (%)	N/A		
	X Walk 1 X Slope (%)	3.1		X Wa	lk 2 X Slope (%)	N/A		
N/A	Ramp inside XWalk1?	N/A	N/A	Ramp	inside XWalk2?	N/A		
	Road Slope (%)	N/A	N/A	Clear	Space?	N/A		
	Road X Slope (%)	N/A	N/A	Clear	Space to XWalk (in)	N/A		
N/A	Any Obstructions?	N/A	N/A	Storm	n Grate/Utility Hazard?	N/A		
	Obstruction Type			Storm	n Grate/Utility Type			
		N/A				N/A		
			Yes	Surfa	ce Condition? (G/P)	Good		
<b>5</b> 4 5

Possible Solutions: Remove & Replace Entire Ramp. Surveyor Notes: N/A PROW/ADA: Not Found, R304.2.2, R304.5.3

Total Cost:	\$ 1850.00
